ARMY MOTORS

OCTOBER 1944

NUMBER 7

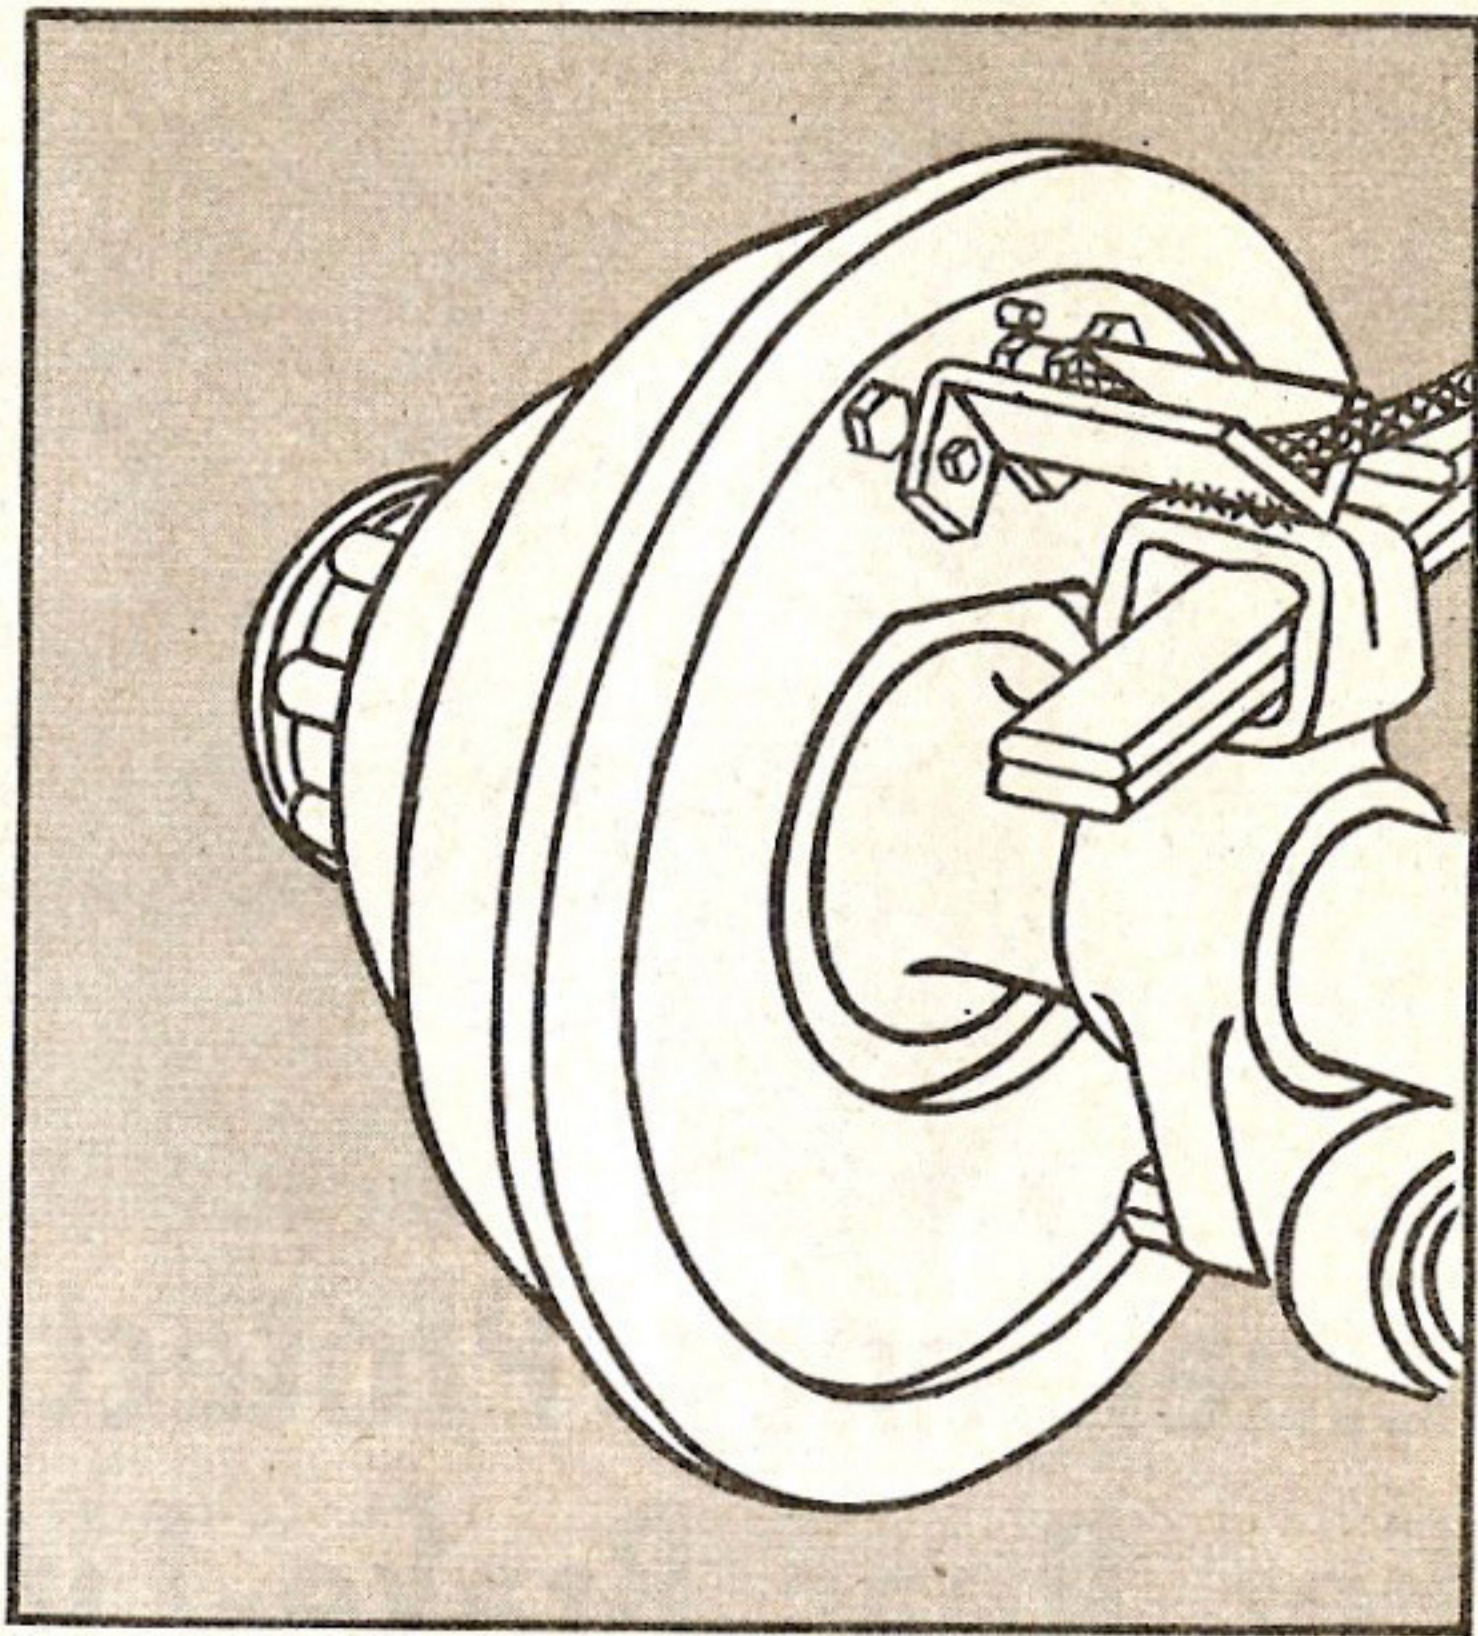
Fig. 5—Bolt one end to the backing plate using the brake-cylinder mounting-bolts (size of the bolts should agree with the thickness of the angle iron), and weld the other end on top the spring guide-bracket. Now your brake line's well protected.

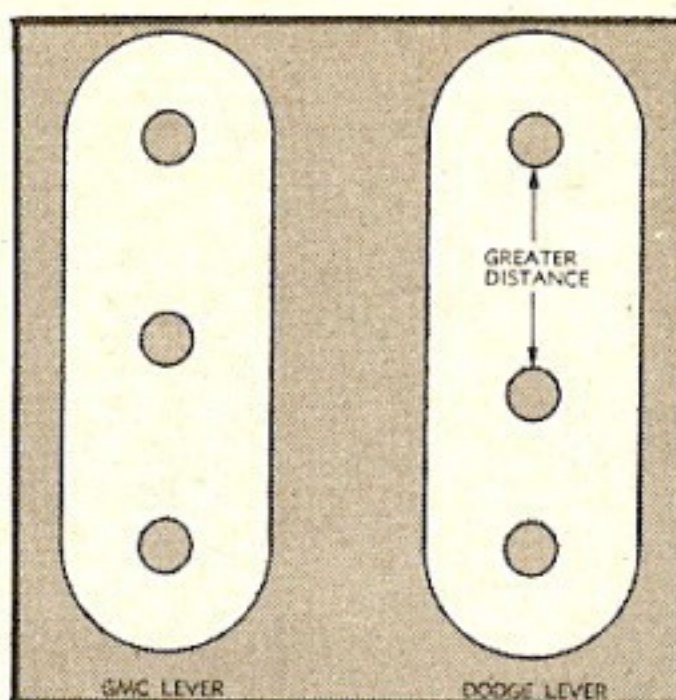
You'll know they're not interchangeable the minute you use the Dodge part on the GMC because it'll be noisy, hard to shift, and keep jumping out of gear. In a short time this condition will chew off all the gear teeth, then even the **right** lever won't do any good.

There's a difference in the levers (see Fig.)—enough difference to show you in black-and-white they're not made to replace each other. So save the Dodge lever for the Dodge and use a GMC lever (Item Stock No. G057-02-74288, Lever, shifter-shaft de-

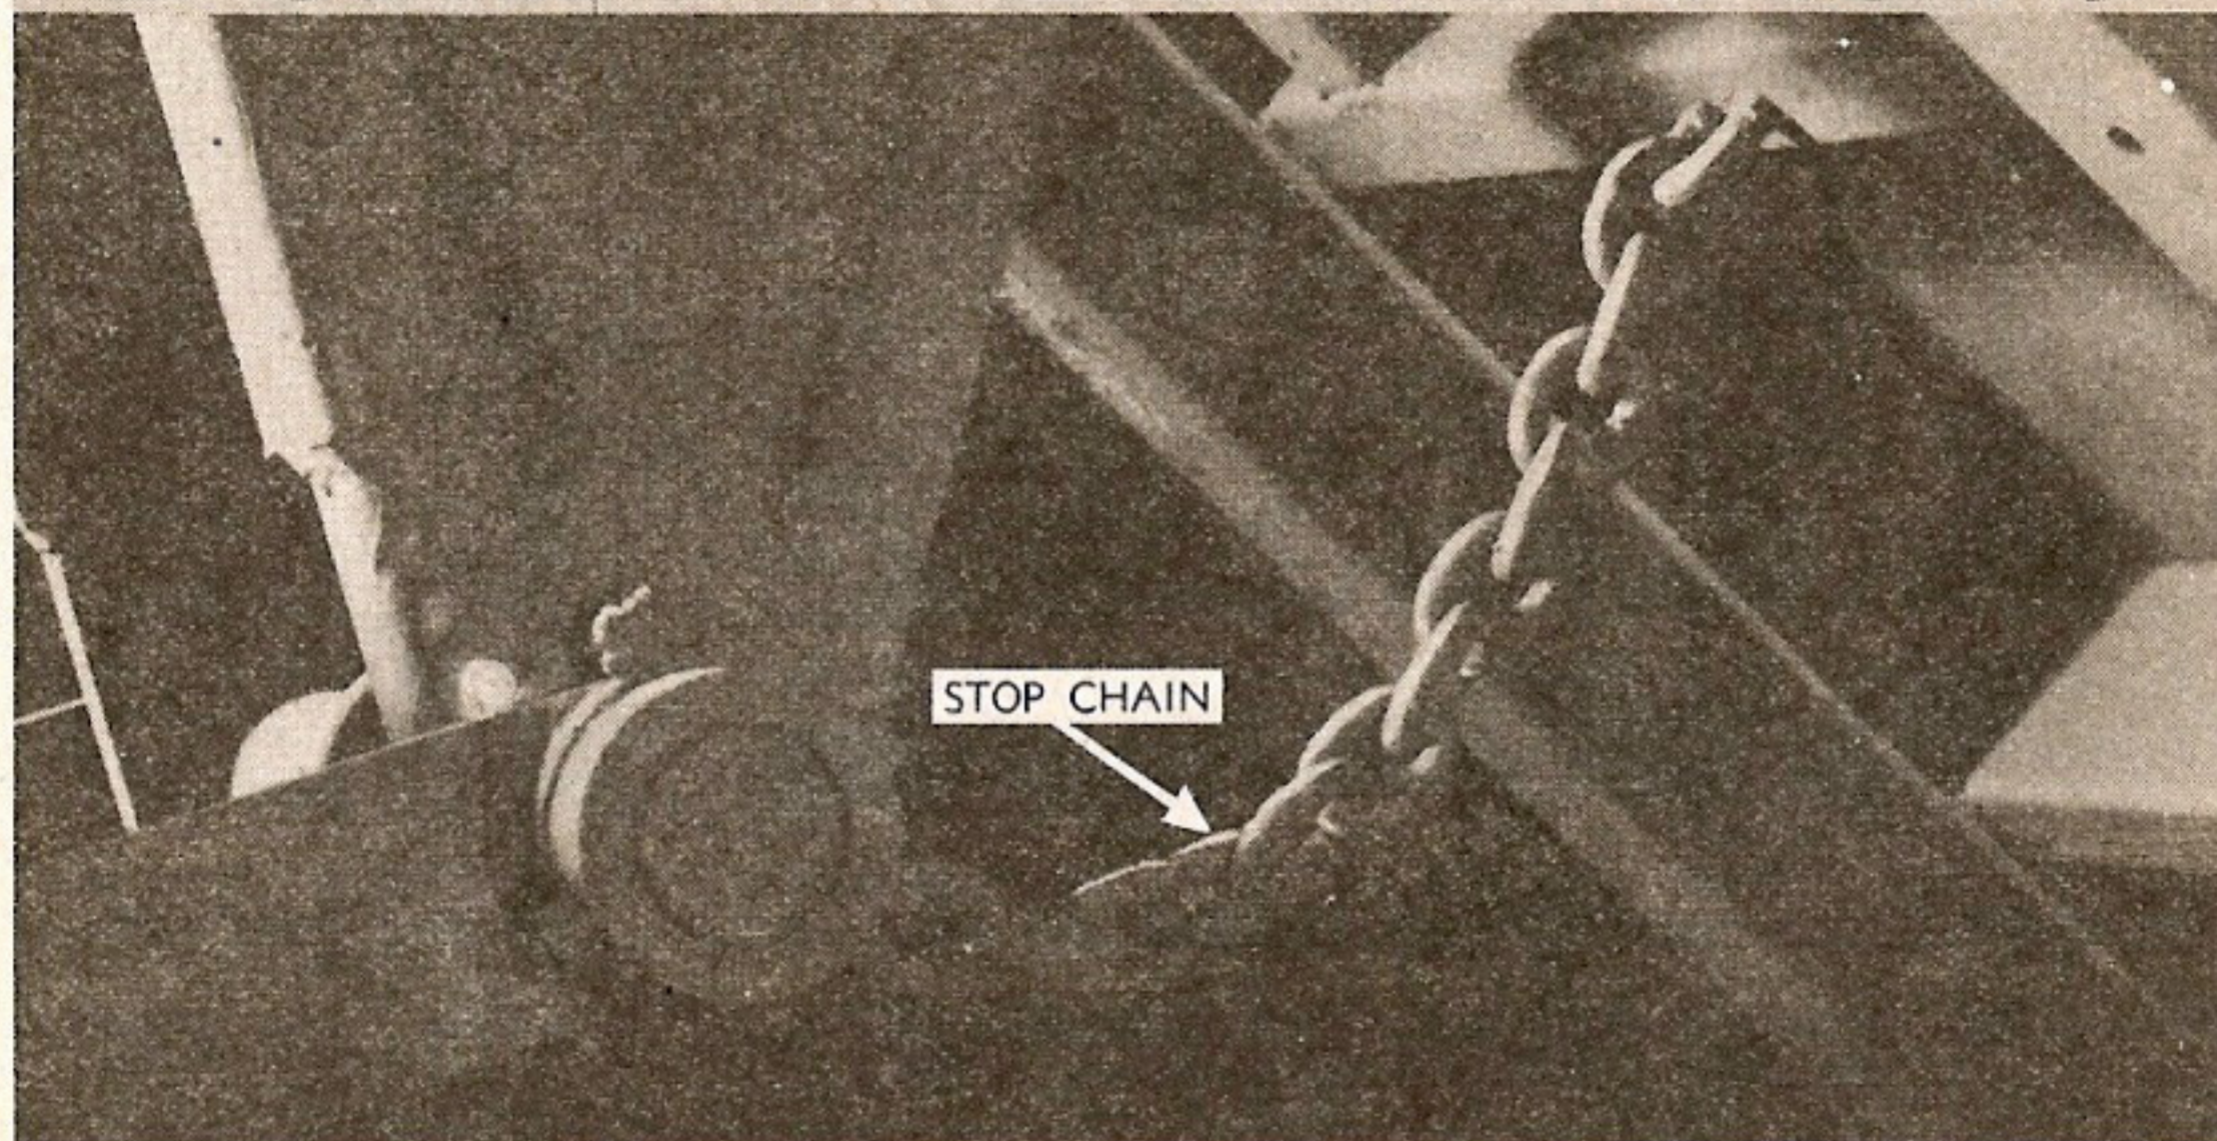
When you're dumping a load down hill, slackness in the stop chain (Fig. 1 above) may cause "over travel" of the hoist-cylinder piston and you'll find yourself with a fractured hoist-cylinder head. Drive the truck on level ground, raise the body with the hoist to its full limit of travel and check the stop chain. If it isn't taut, taut-en it.

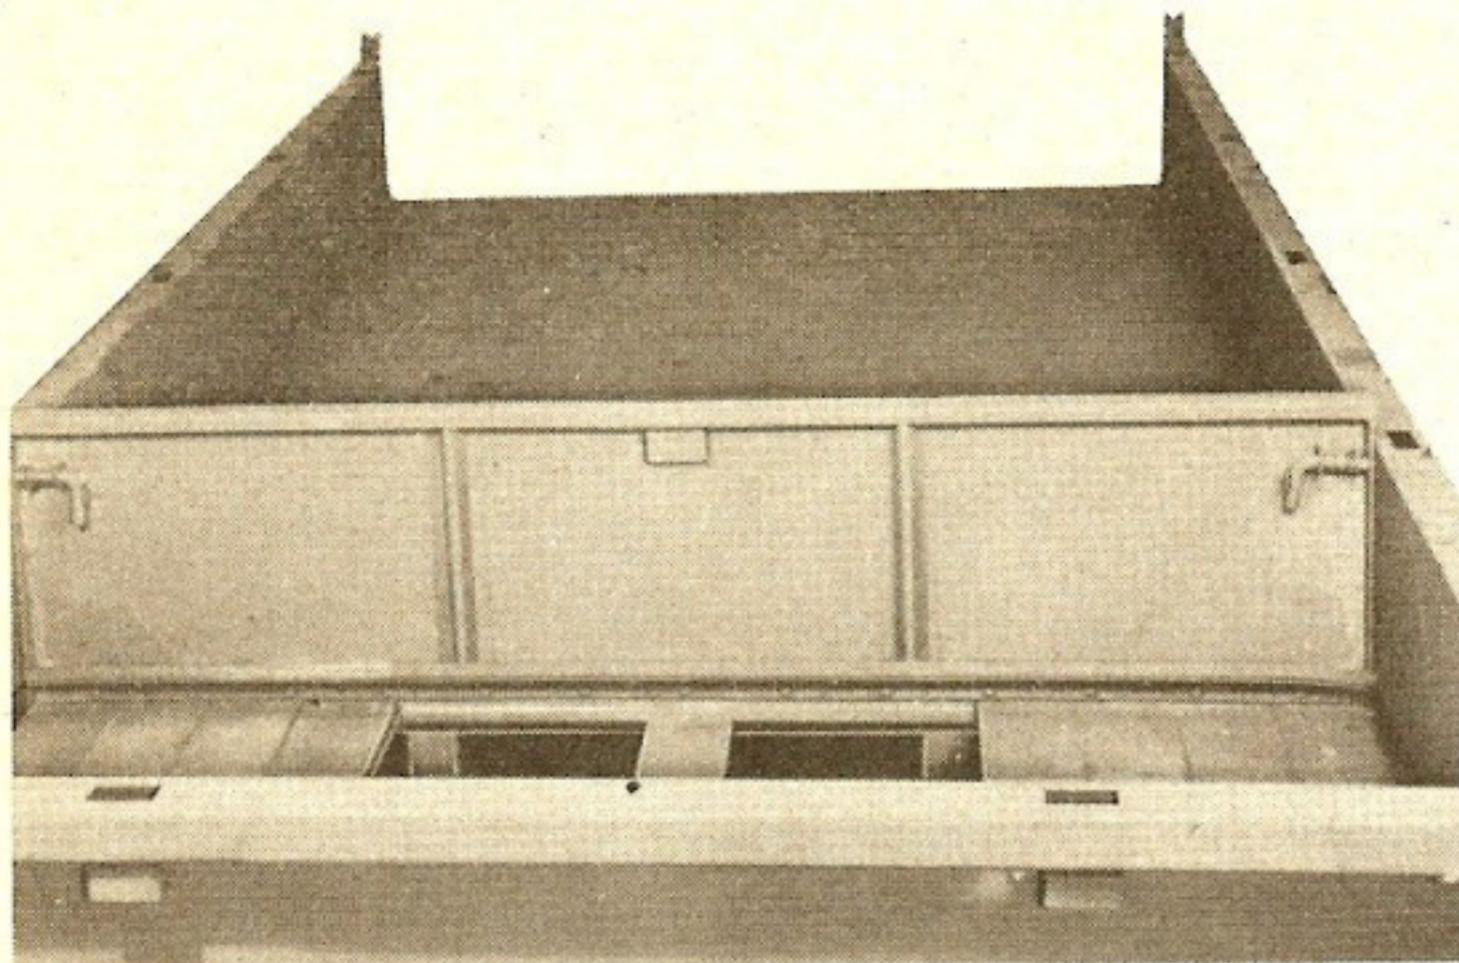
Fig. 3—The partition should always be up and locked in position when you are using the 2½-ton GMC as a dump truck.

If you overload your 2½-ton GMC past the 10,000 lb. mark, don't start crying when your hoist fails. That's the maximum load the hoist was built for. There's a partition that lies flush with the floor that's awful easy to overlook. Raise it and fasten at right angles to the floor (Fig. 3) when you're using the GMC as a dump truck with either Gar Wood or Heil hoists.

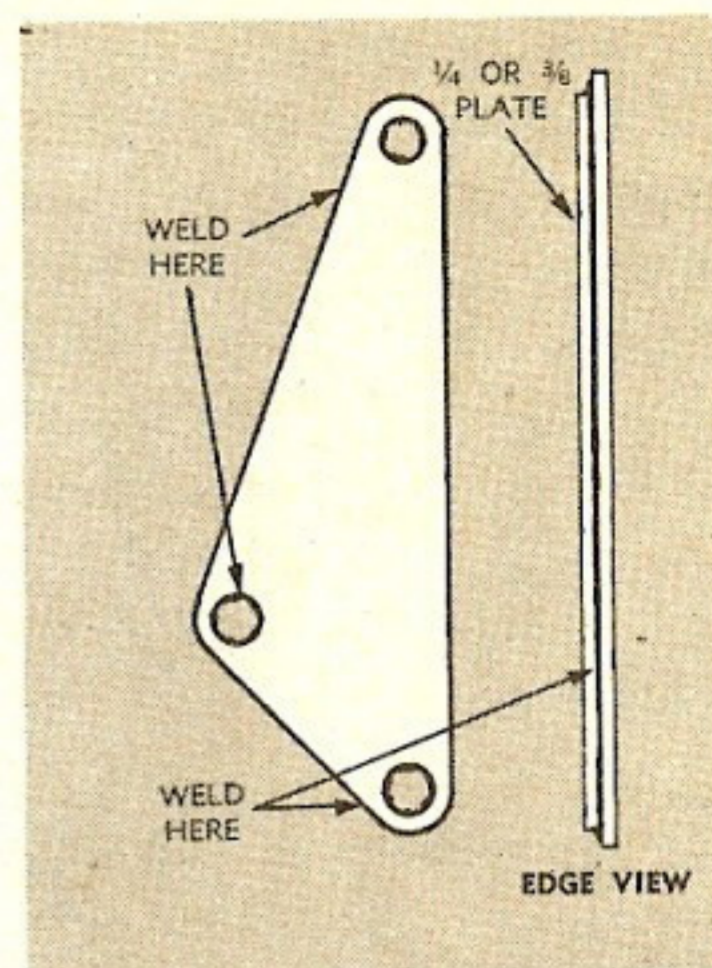
Fig. 4—Weld the scrap plate on in the three spots indicated for reinforcement of the lift arms (using ¼" to ⅜" steel)

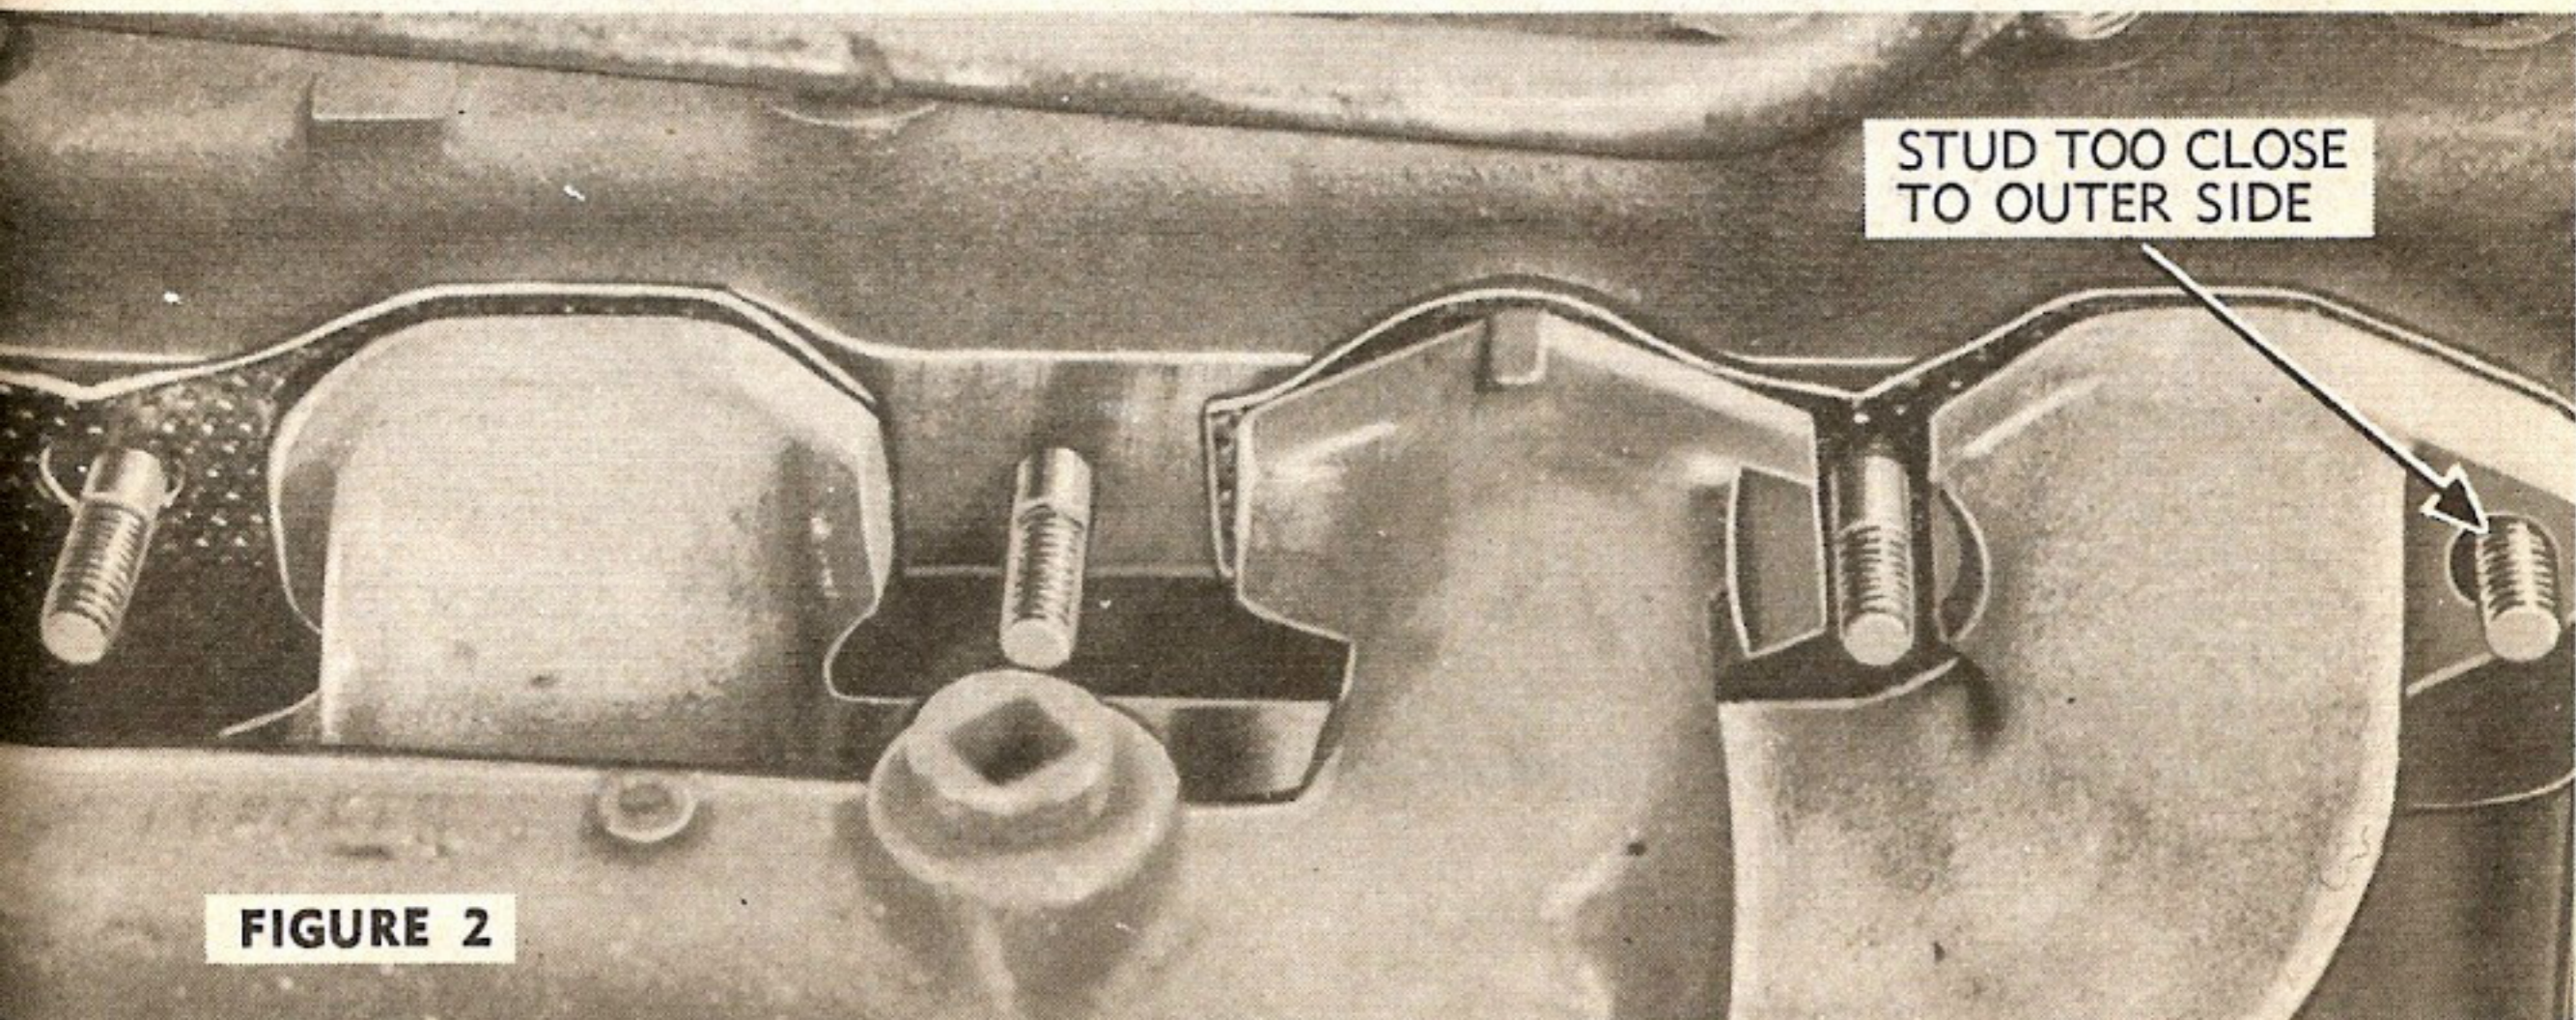
One of the main reasons for all the trouble is that when the manifold gets hot and expands, the mounting studs, clamps, and washers bind and distort the manifold. When this happens, it's just a matter of time till there's a crack. The best way to prevent that from happening is to check the stud, clamp, and washer clearances yourself—and if they aren't right, get your higher echelon shop to rework them.

tween each washer edge and unmilled face of the manifold flange (see Fig. 1). If it's less than 1/16" it's bound to cause trouble. Likewise, the studs should have 1/16" clearance on all sides of the hole (you'll remove the nuts and washers from the studs to check this). The end mounting studs are apt to be too close to the lower and outer sides (see Fig. 2).

Be sure to check the flange faces of the exhaust manifold where each manifold clamp rests against a flange (take another look at Fig. 1). There's so little clearance there on some of the manifolds, that the clamp climbs

up the flange neck as the manifold expands. The leverage developed is enough to snap the studs, so make sure the face under the clamp is smooth and roomy enough so the manifold can slide free and easy during expansion.

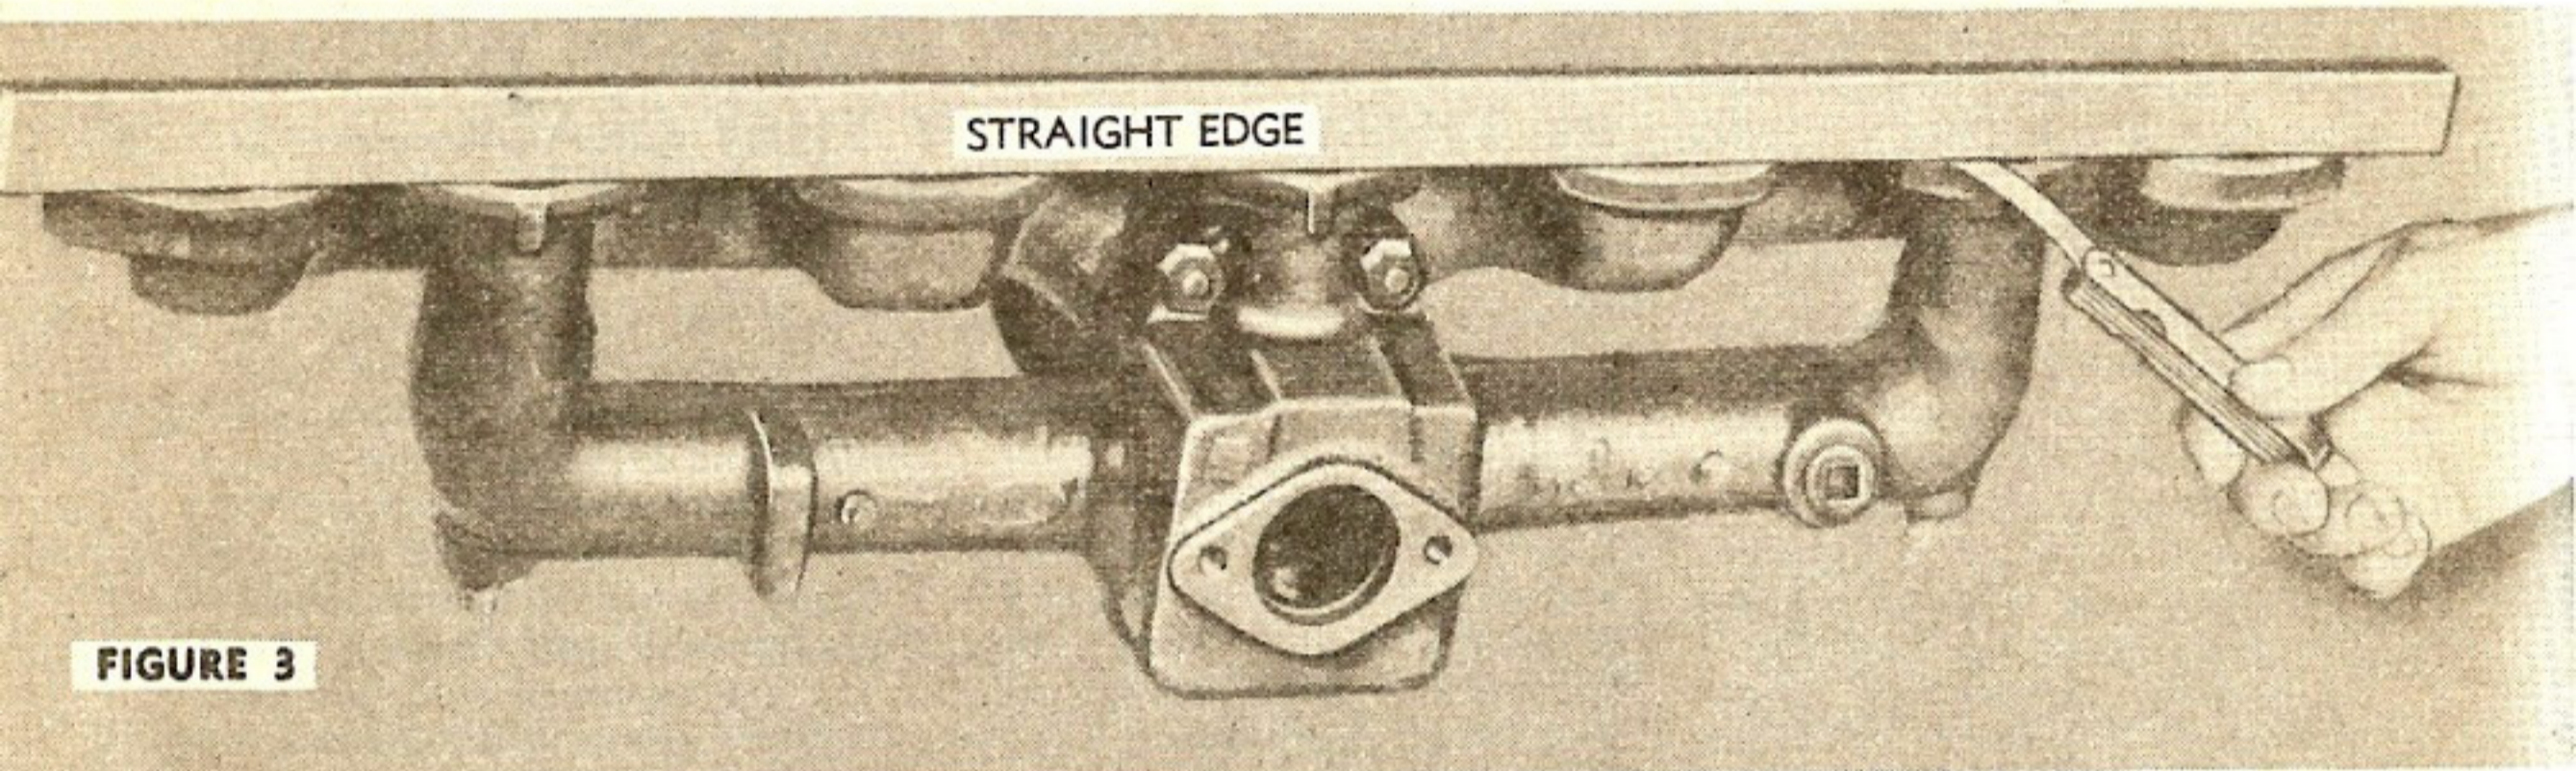
FIGURE 3

If you're smart, you'll also check the port-flange face-alignment whenever you remove an exhaust manifold because of a leaky gasket. Line it up with a straight edge and use a feeler gage (Fig. 3). If one or more of the flange faces is the least bit off ($1/32''$), get your higher echelon shop to do the necessary refacing.

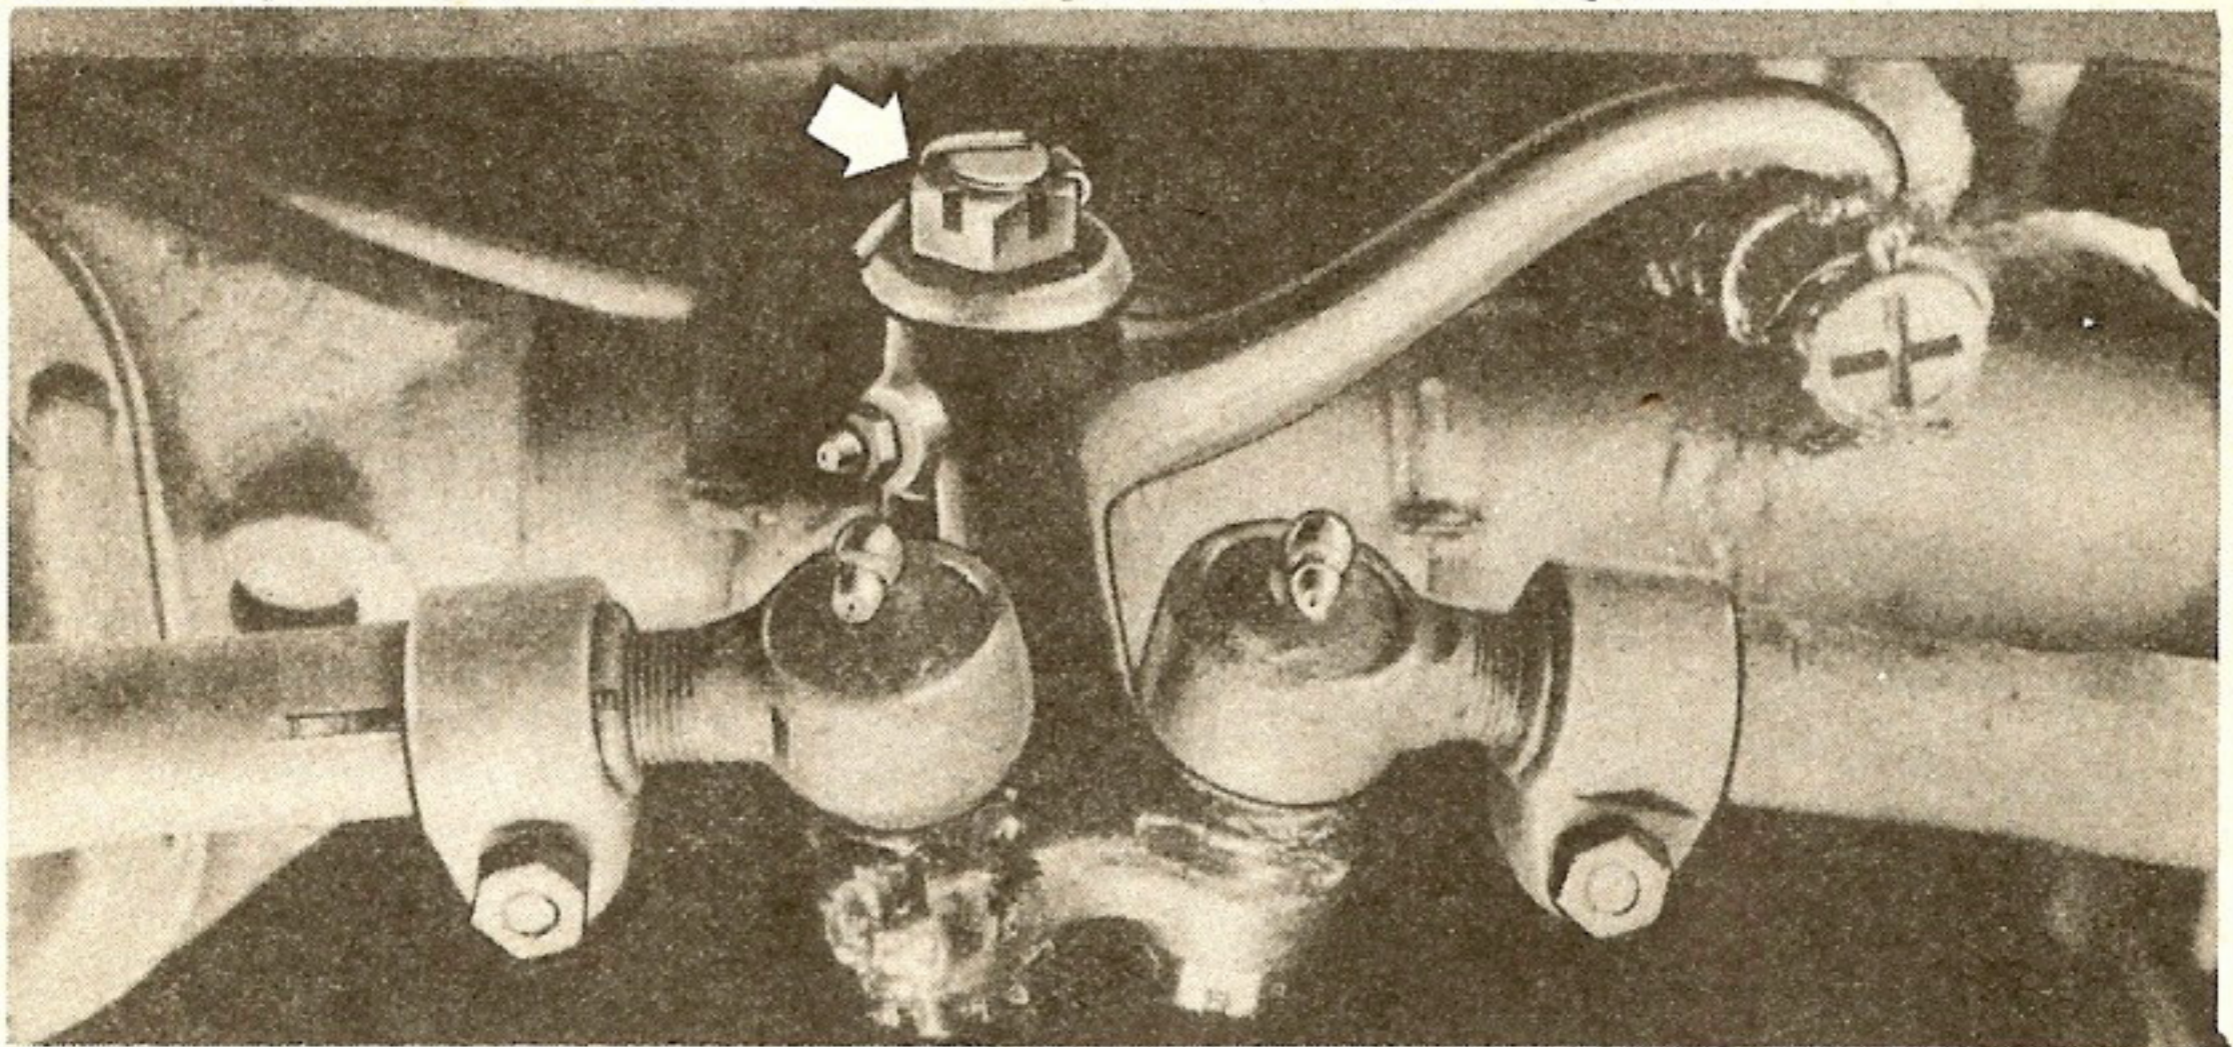
This odd little assembly sitting up front of the jeep with its chin out (see Fig.) is on the dirty end of the ride. If there's any water at all in the road, the bell crank picks it up. Water is the biggest cause of trouble—it gets into the bell-crank bearing, mixes with the grease in there, turns the grease to mayonnaise thus cheating the bearing out of its lubrication, and ruining the bearing.

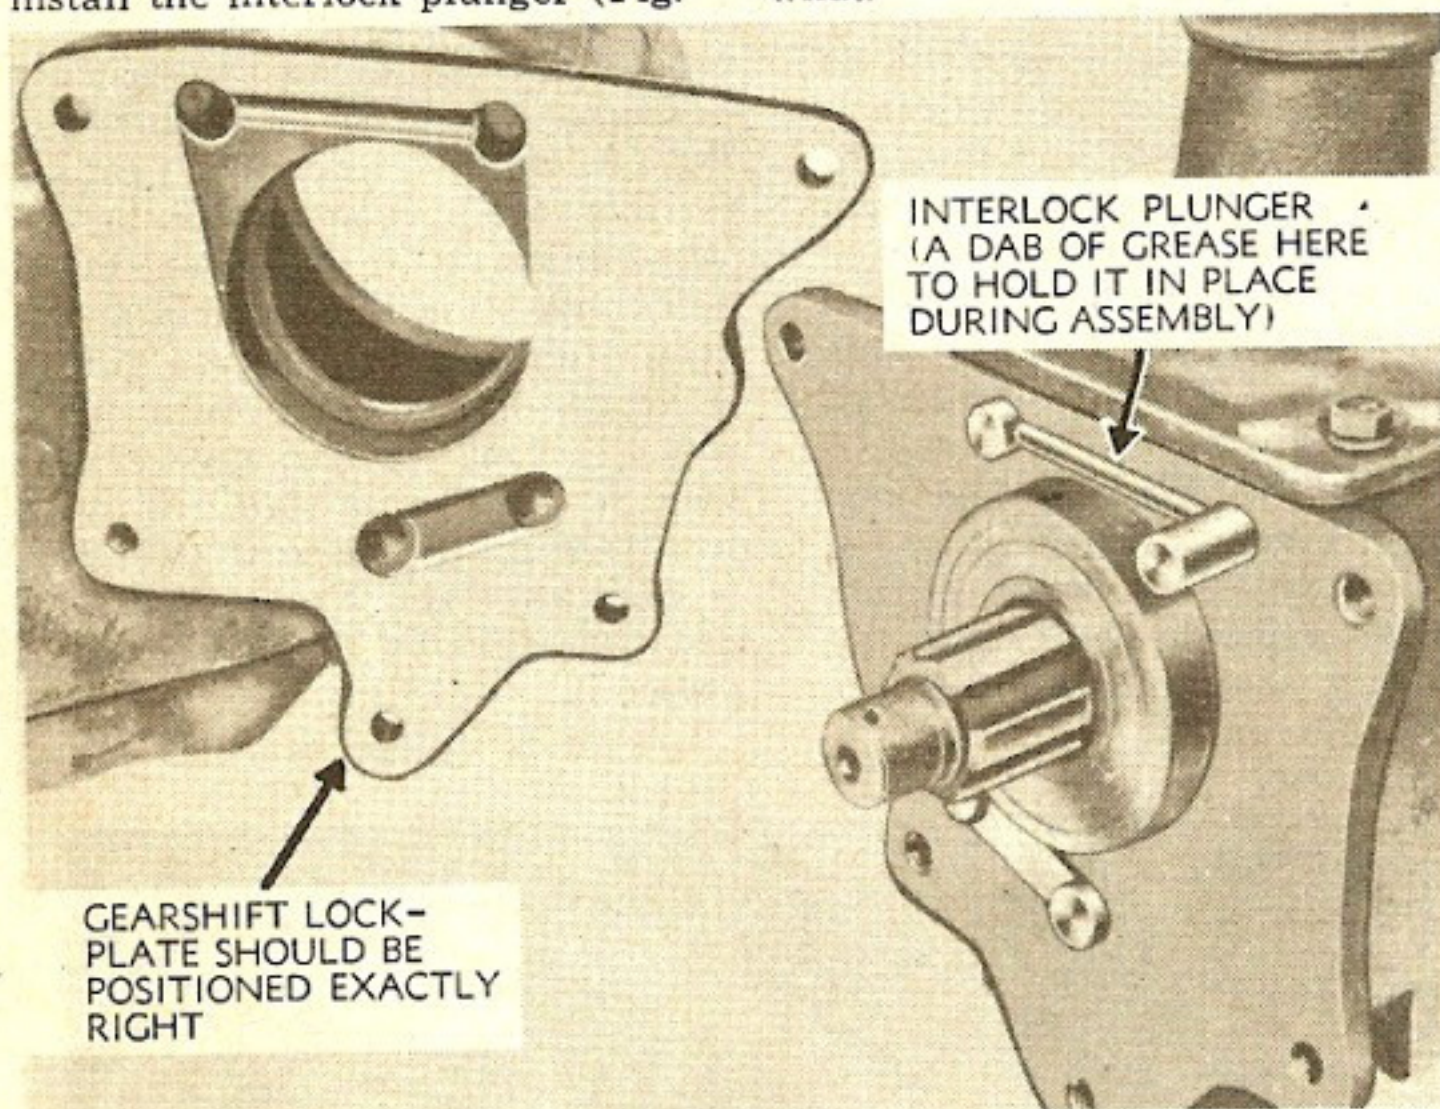
Figure 1

Watch out when you're installing the gearshift lock plate, too. If the lock plate (Fig. 1) isn't positioned right, it'll be sheared off when the transfer case is drawn up against the transmission. And if the edge of the lock-plate enters between the face of the transmission assembly and transfer case, the two units can't be drawn up on their gaskets—result: misalignment and a grease leak.

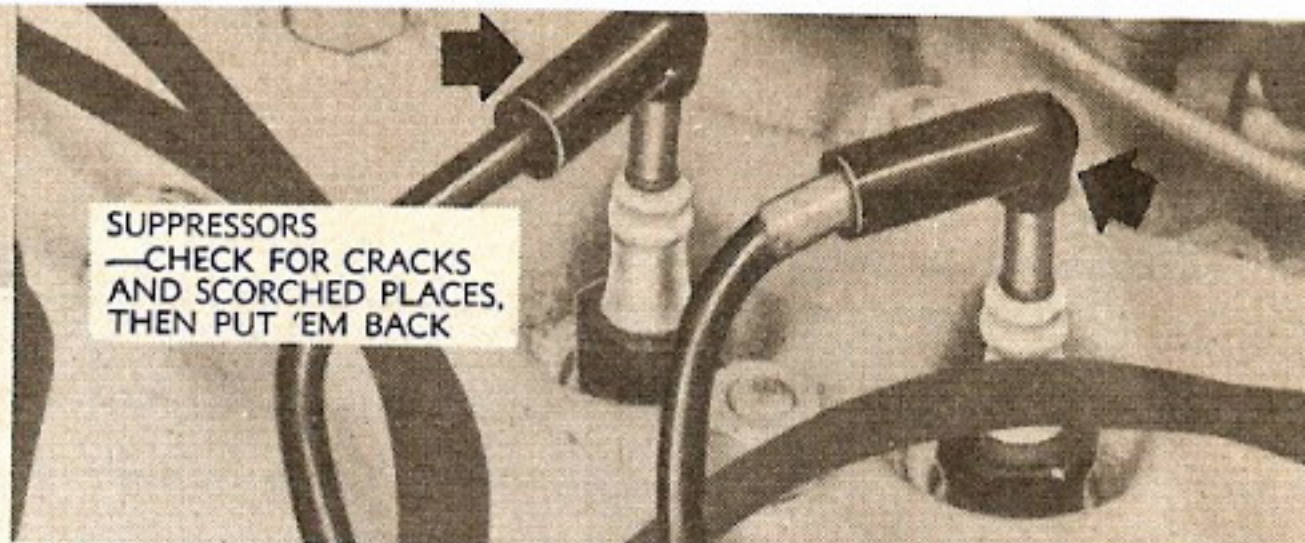
SUPPRESSORS
—CHECK FOR CRACKS
AND SCORCHED PLACES,
THEN PUT 'EM BACK

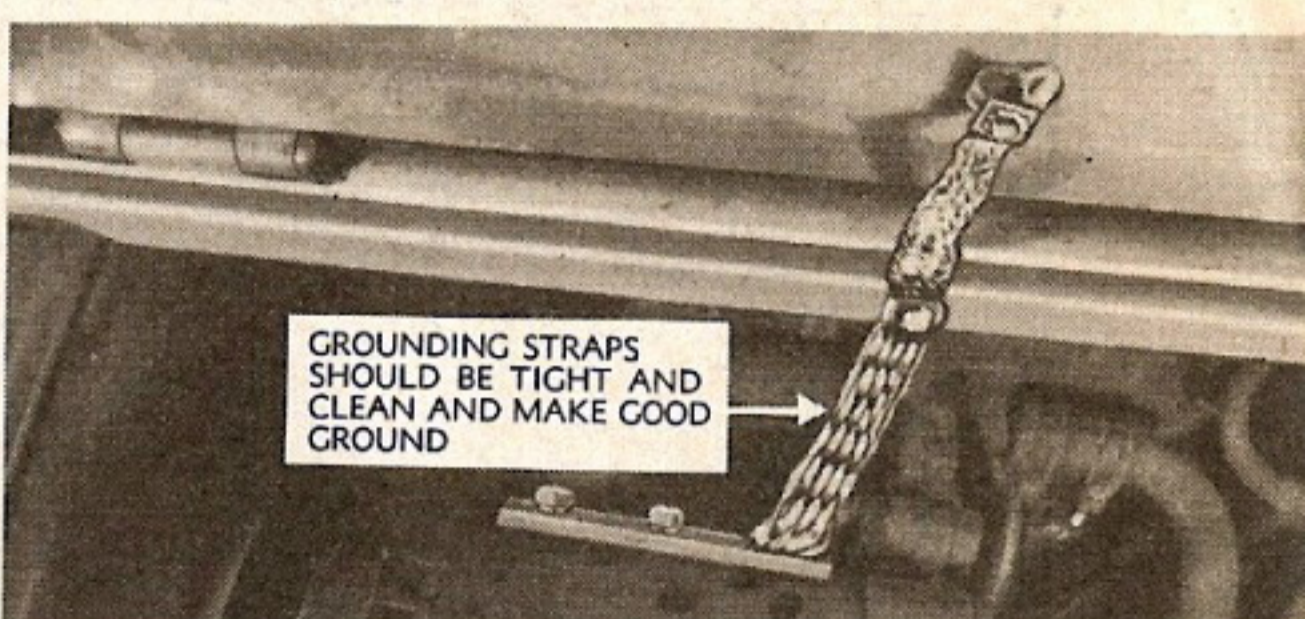
Not only do vehicle assemblies suffer when small parts are left out—even radio reception can be destroyed if suppressors or grounding straps (Fig. 3) aren't replaced. Don't blame the radio when a lot of static wiggles in—check for loose grounding straps; see that all the suppression shielding was reinstalled; be sure all the internal-external washers were put back (and ordinary spring lockwashers should not be substituted in their place). The same holds true for cadmium or lead capscrews and bolts—plain capscrews and bolts should not be substituted.

GROUNDING STRAPS
SHOULD BE TIGHT AND
CLEAN AND MAKE GOOD
GROUND
