Senior Citizen PM

(Editor's note: PS first wrote about the TA-312/PT 31 years ago this month in Issue 211. We've covered maintenance issues about it many times since. But as long as it remains one of the workhorses of the Army communications system, and as long as there are "green" troops using it, we'll still put out the good preventive maintenance word.)

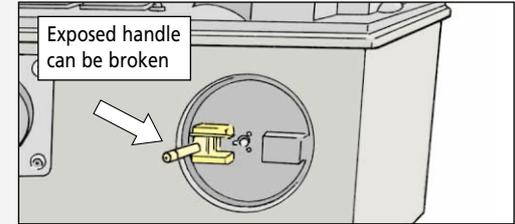
A broken or lost generator handle probably means an operator decided sudden stops or cranking the handle backwards was fun. Or maybe they just forgot to tuck the handle in when they were done cranking.
