FINAL REPORT OF ENGINEER DESIGN TEST OF SHELTER, ELECTRONIC EQUIPMENT, S-153, AND THE AN/GRC-122 SYSTEM (ROAD SHOCK AND VIBRATION AND RAILROAD HUMP TEST)

REPORT NO. DPS-1357

JUNE 1964

DEVELOPMENT AND PROOF SERVICES

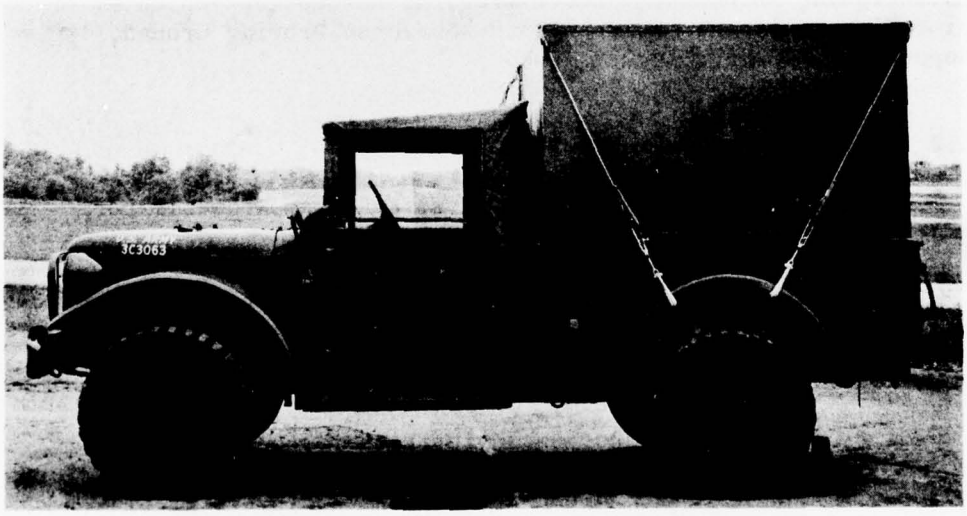
Figure 1: Shelter Mounted on Truck, Cargo, 3/4-Ton, 4x4, M37.

The shelter is of aluminum construction and is mounted on three equally-spaced longitudinal skids. Brackets are located on the top four corners for attaching lift or tiedown slings. Figure 1 is a general view of the shelter mounted on an M37 truck.

There was no indication of instability or other adverse conditions at any time during this test.

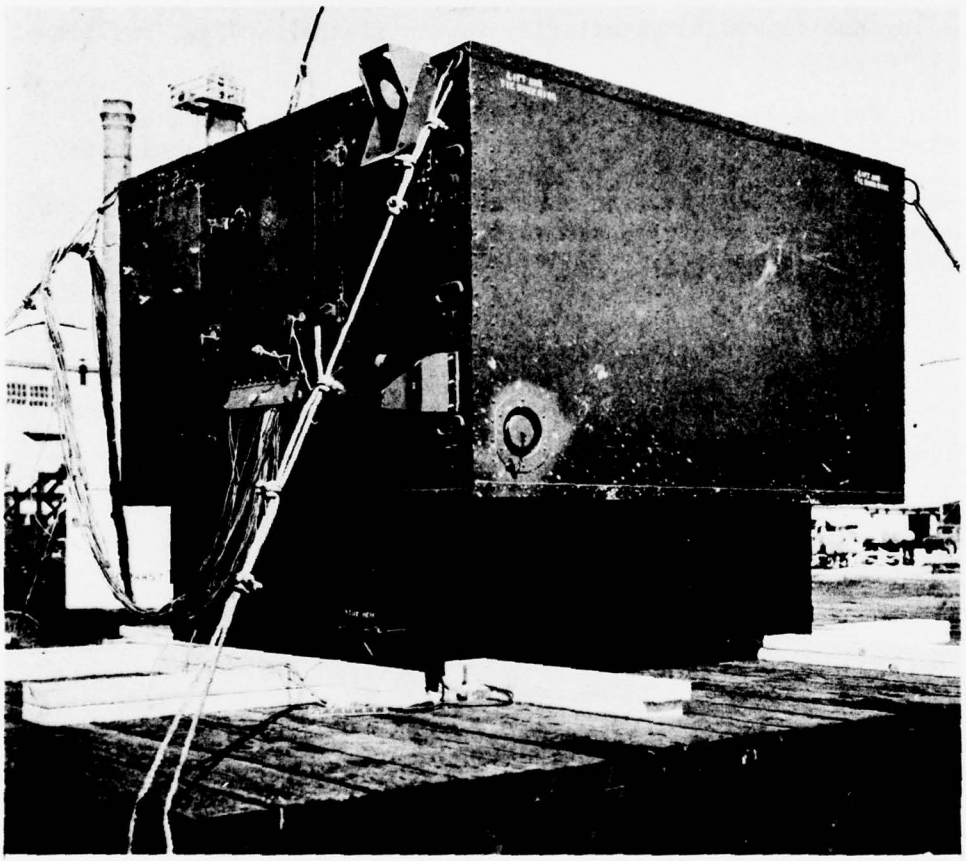
Figure 5: Accelerometers Mounted on Railroad Car Floor Adjacent to Blocking and Over-all View of Shelter Tiedown.

There was no damage to the exterior of the shelter, the blocking or the tiedowns as a result of shock generated during the railroad humping test.

There was no apparent damage to the shelter blocking as a result of impacts up to 9.2 mph; however, the equipment-mounting fixtures within the shelter were inadequate in some instances. A list of deficiencies noted after each impact follows:
