ARMY MOTORS

OCTOBER 1944

NUMBER 7

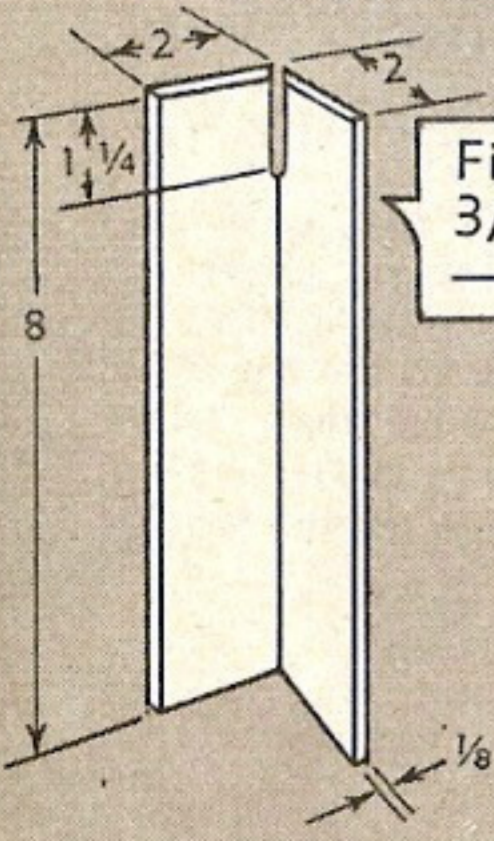
Fig. 1—You can use 3/16" or 1/4" angle iron—but 1/8" thick is best.

Fig. 2—Hacksaw down the center 1 1/4" and bend back both ends of the split.

Fig. 3—Saw off the outer corners (those marked 'X').

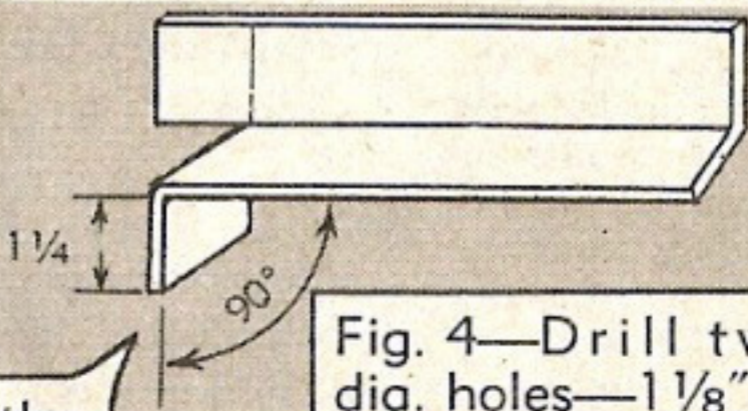
Fig. 4—Drill two 3/8" dia. holes—1 1/8" apart.

Drill a 3/8" dia. hole in each bent section—about 1 1/8" apart, measured from the center of each hole—like Fig. 4.

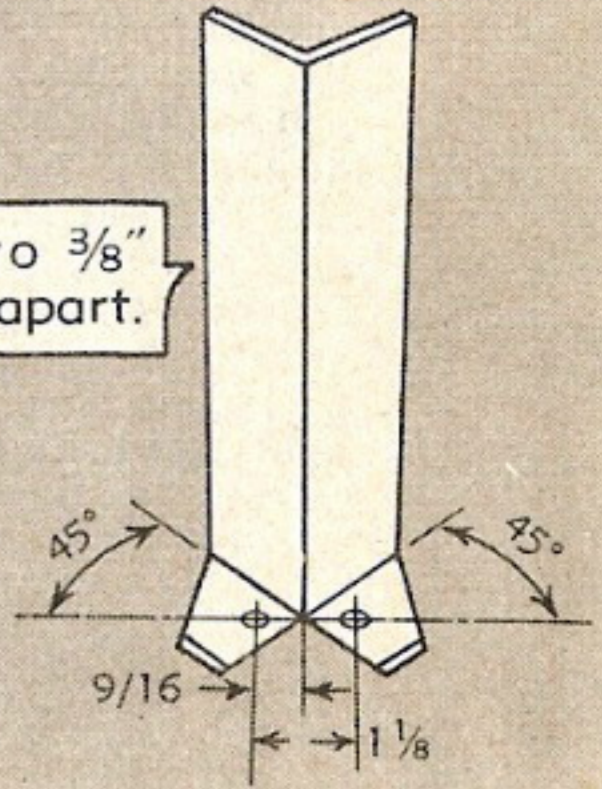
Fig. 5—Bolt one end to the backing plate using the brake-cylinder mounting-bolts (size of the bolts should agree with the thickness of the angle iron), and weld the other end on top the spring guide-bracket. Now your brake line's well protected.

Now for the installation: Fasten the bent end of the angle iron to the wheel backing-plate by using the brake-cylinder mounting-bolts. The bolts should be 5/16x-18x3/4" (Federal Stock No. H1-10-13017) if the angle iron is 1/8" thick. If you're using thicker angle iron, about 3/16" or 1/4", you should use longer bolts—5/16x-18x7/8" (Federal Stock No. H1-10-13018).

Weld the other end of the angle iron on top the spring guide-bracket. The angle iron should cradle the rear brake-line like Fig. 5. In this position you'll get plenty of protection for the line, and even if wire does get wrapped around both the angle iron and the brake line, it won't cut the brake line.

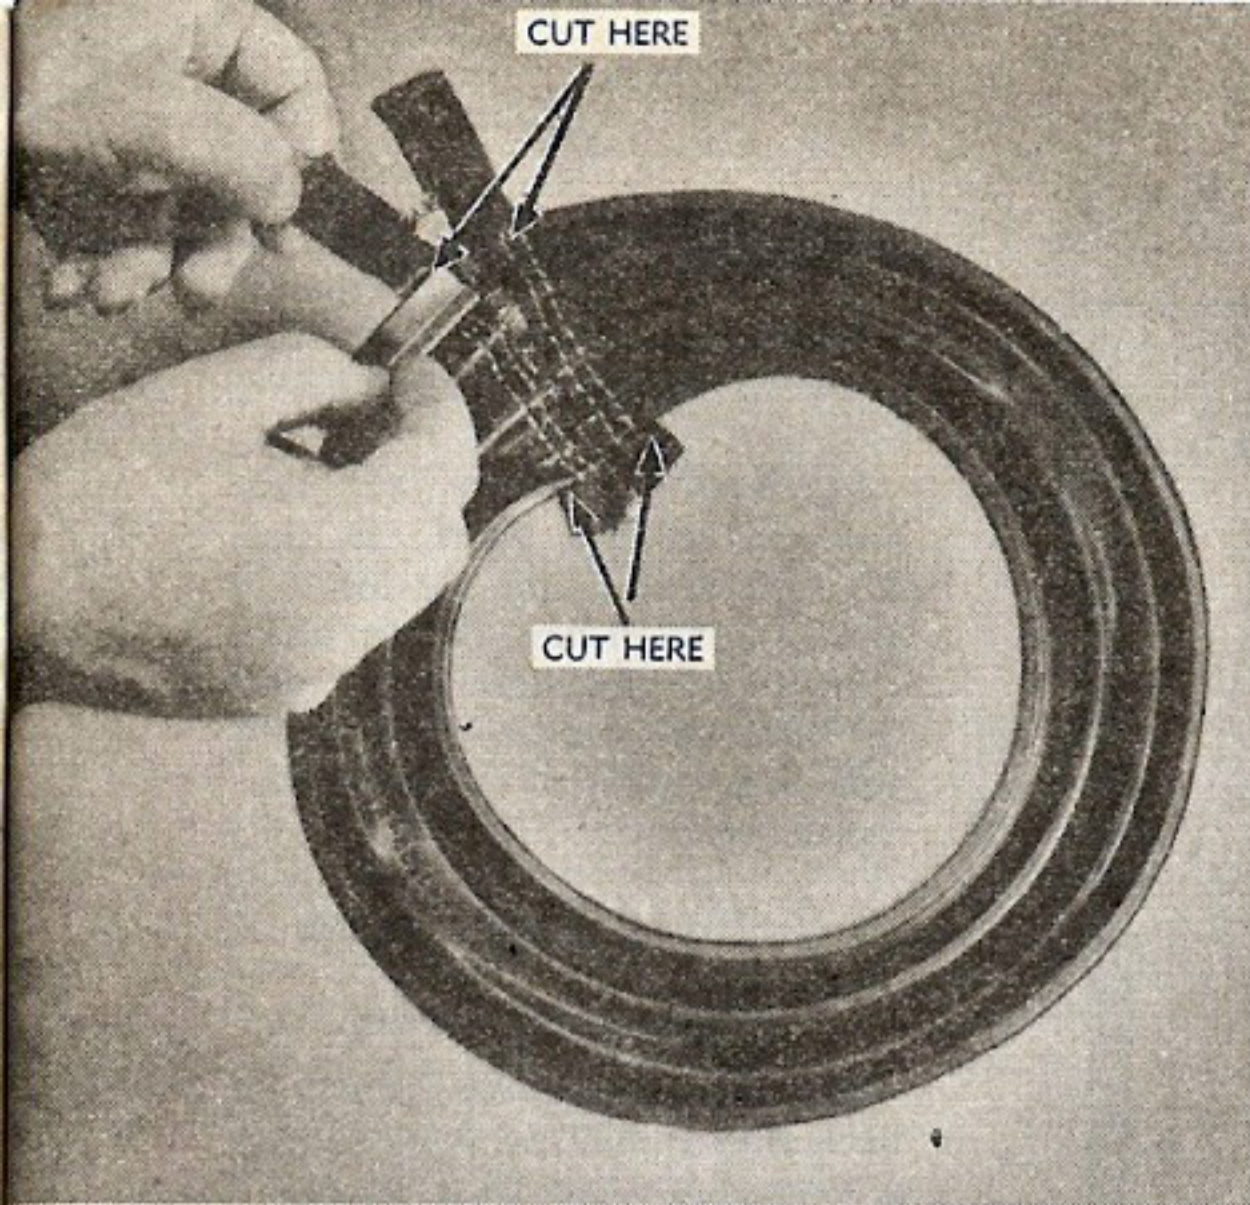
Fig. 1—This is the back side of the steering-knuckle boot with your razor blade already to cut in between the boot and the zipper.

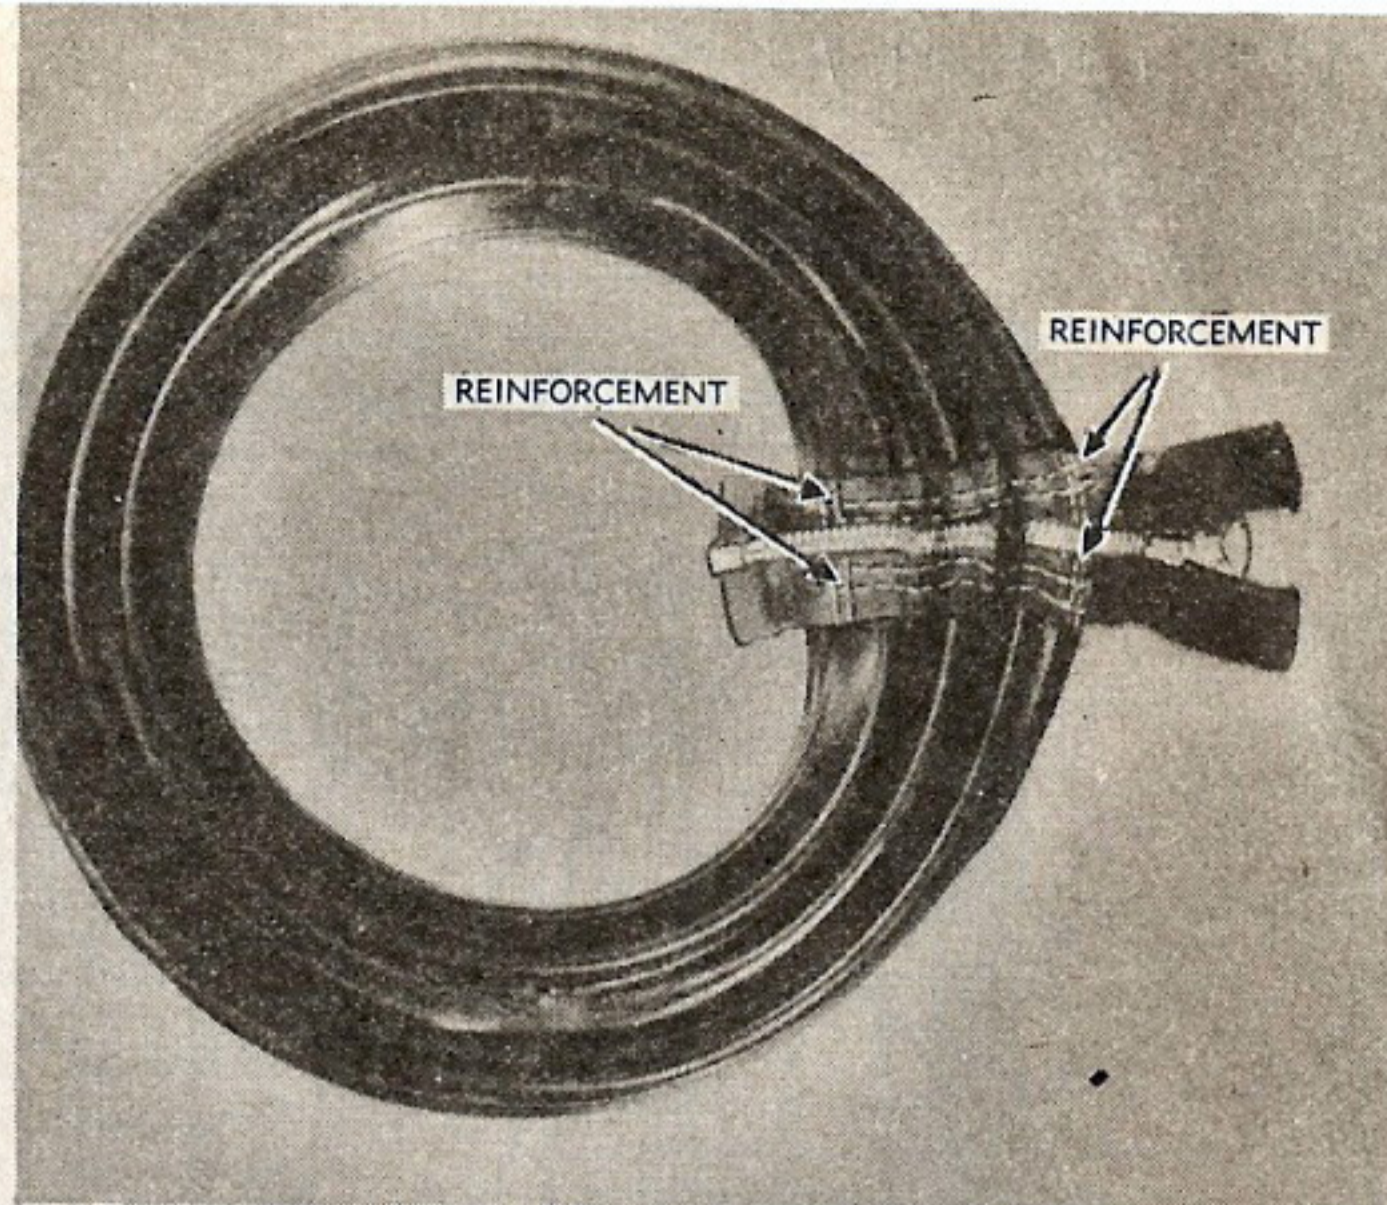
Fig. 2—The boot will look like this when the sewing machine man gets through reinforcing it. Those are the 4 points that take the needle.

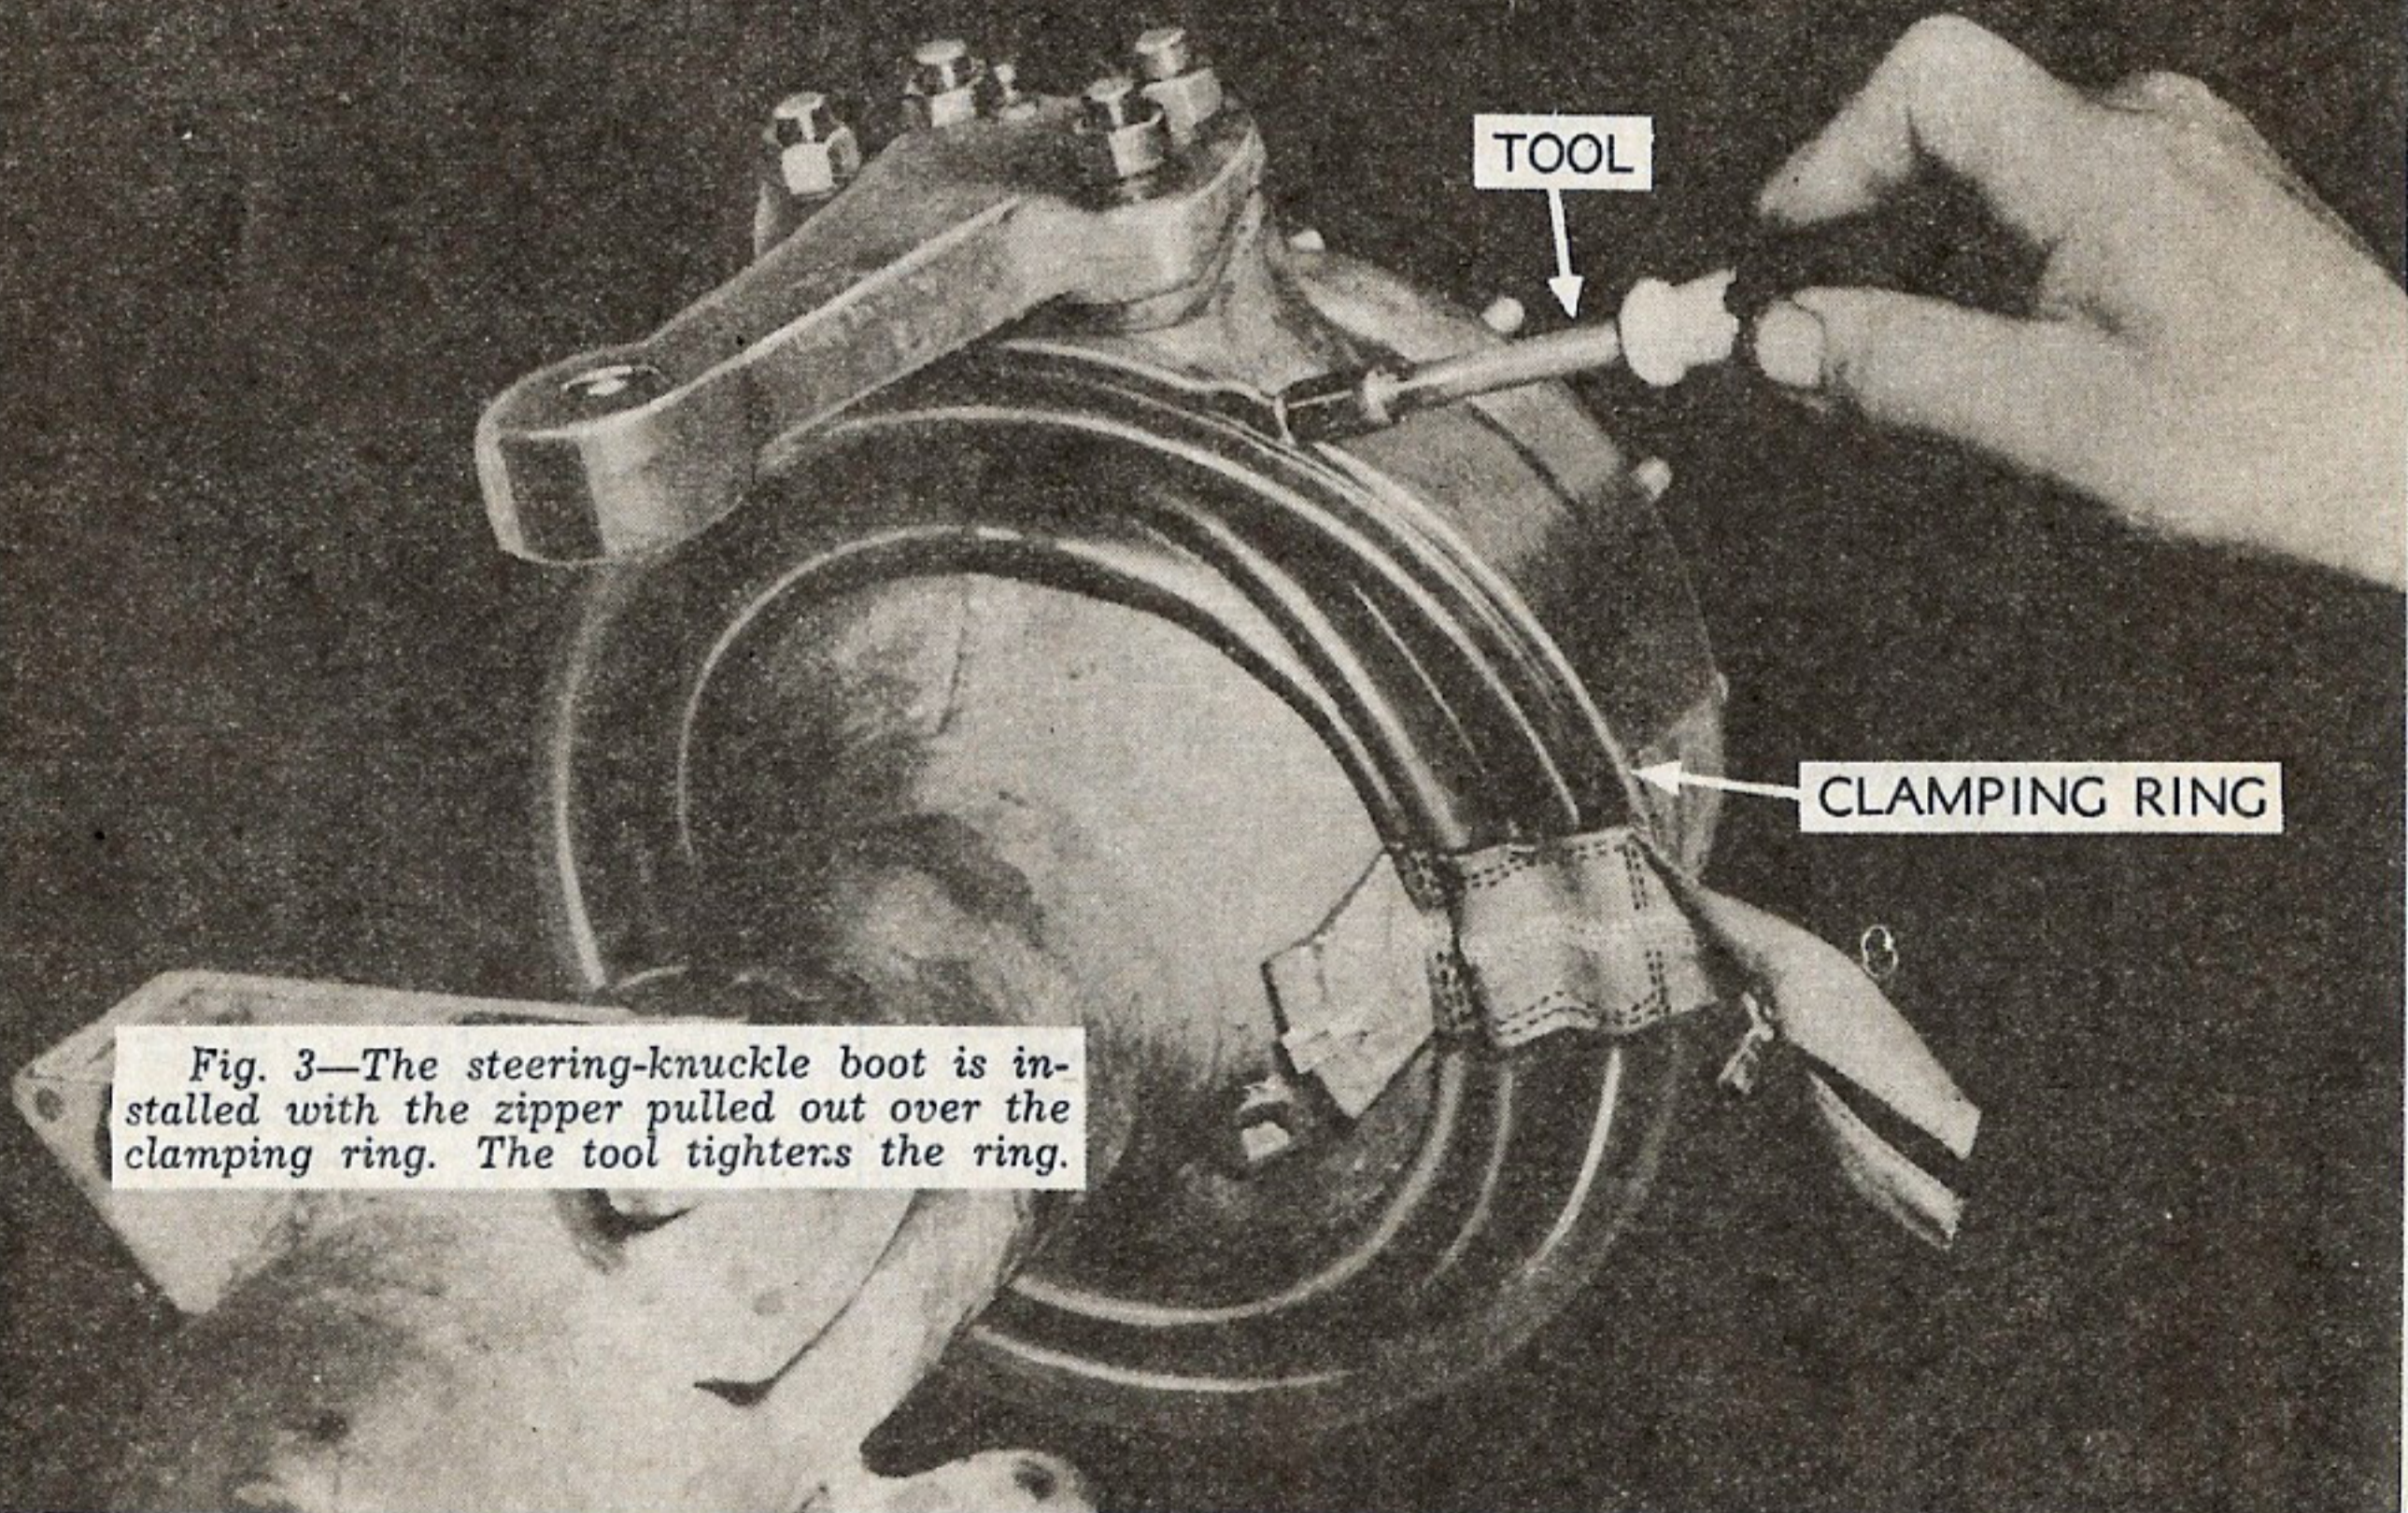
Fig. 3—The steering-knuckle boot is installed with the zipper pulled out over the clamping ring. The tool tightens the ring.

Now you're ready to install the boot. Pull ends of the zipper out over the clamping ring (Fig. 3).

The tool shown in Figure 3 will make it easier to put the boot on.

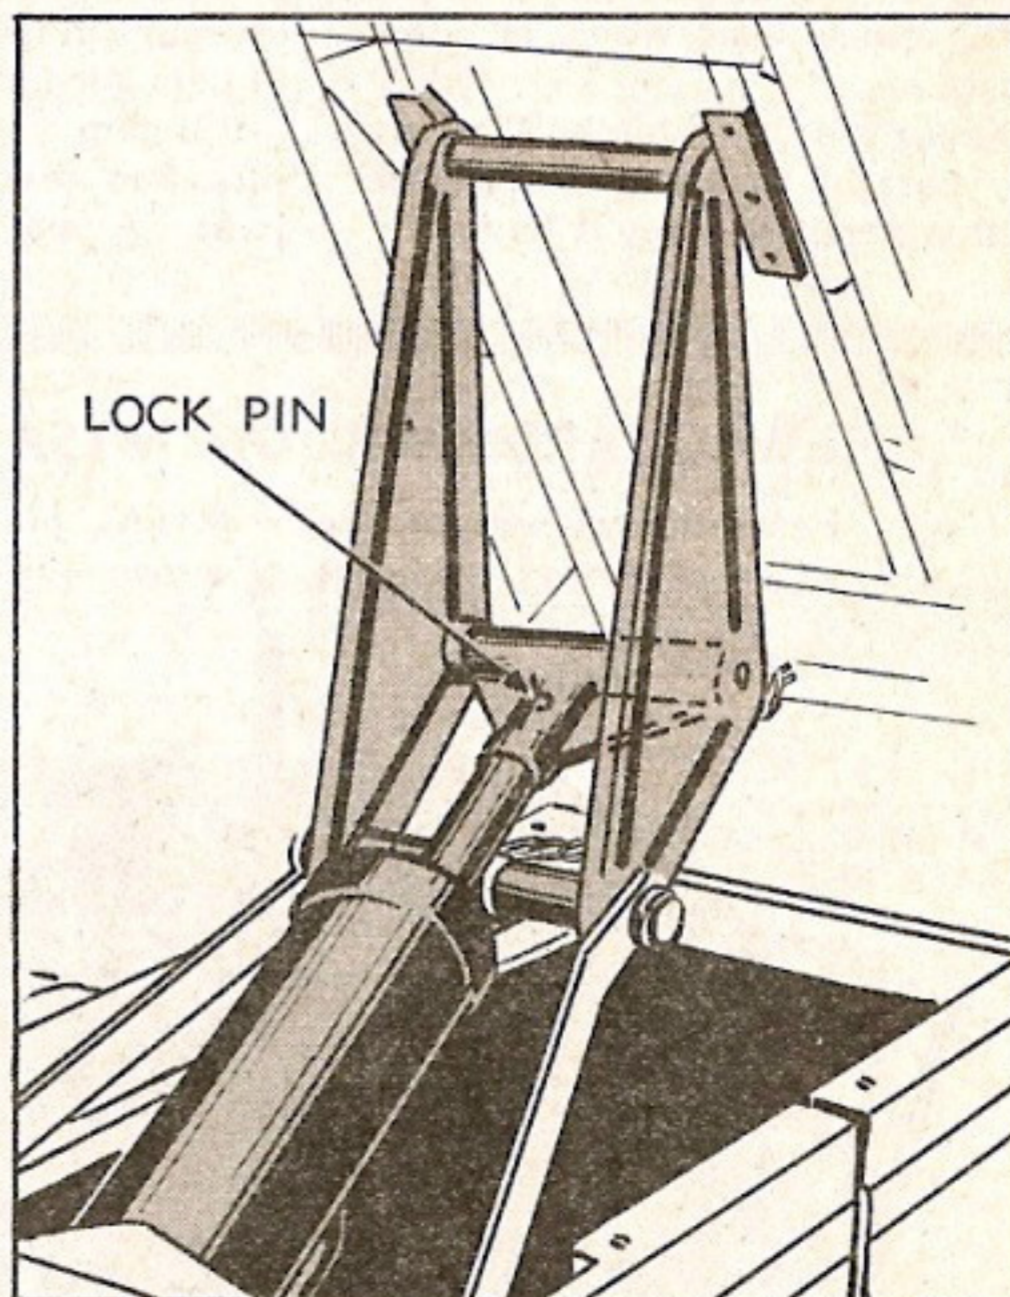
Fig. 3—The partition should always be up and locked in position when you are using the 2½-ton GMC as a dump truck.

If you overload your 2½-ton GMC past the 10,000 lb. mark, don't start crying when your hoist fails. That's the maximum load the hoist was built for. There's a partition that lies flush with the floor that's awful easy to overlook. Raise it and fasten at right angles to the floor (Fig. 3) when you're using the GMC as a dump truck with either Gar Wood or Heil hoists.

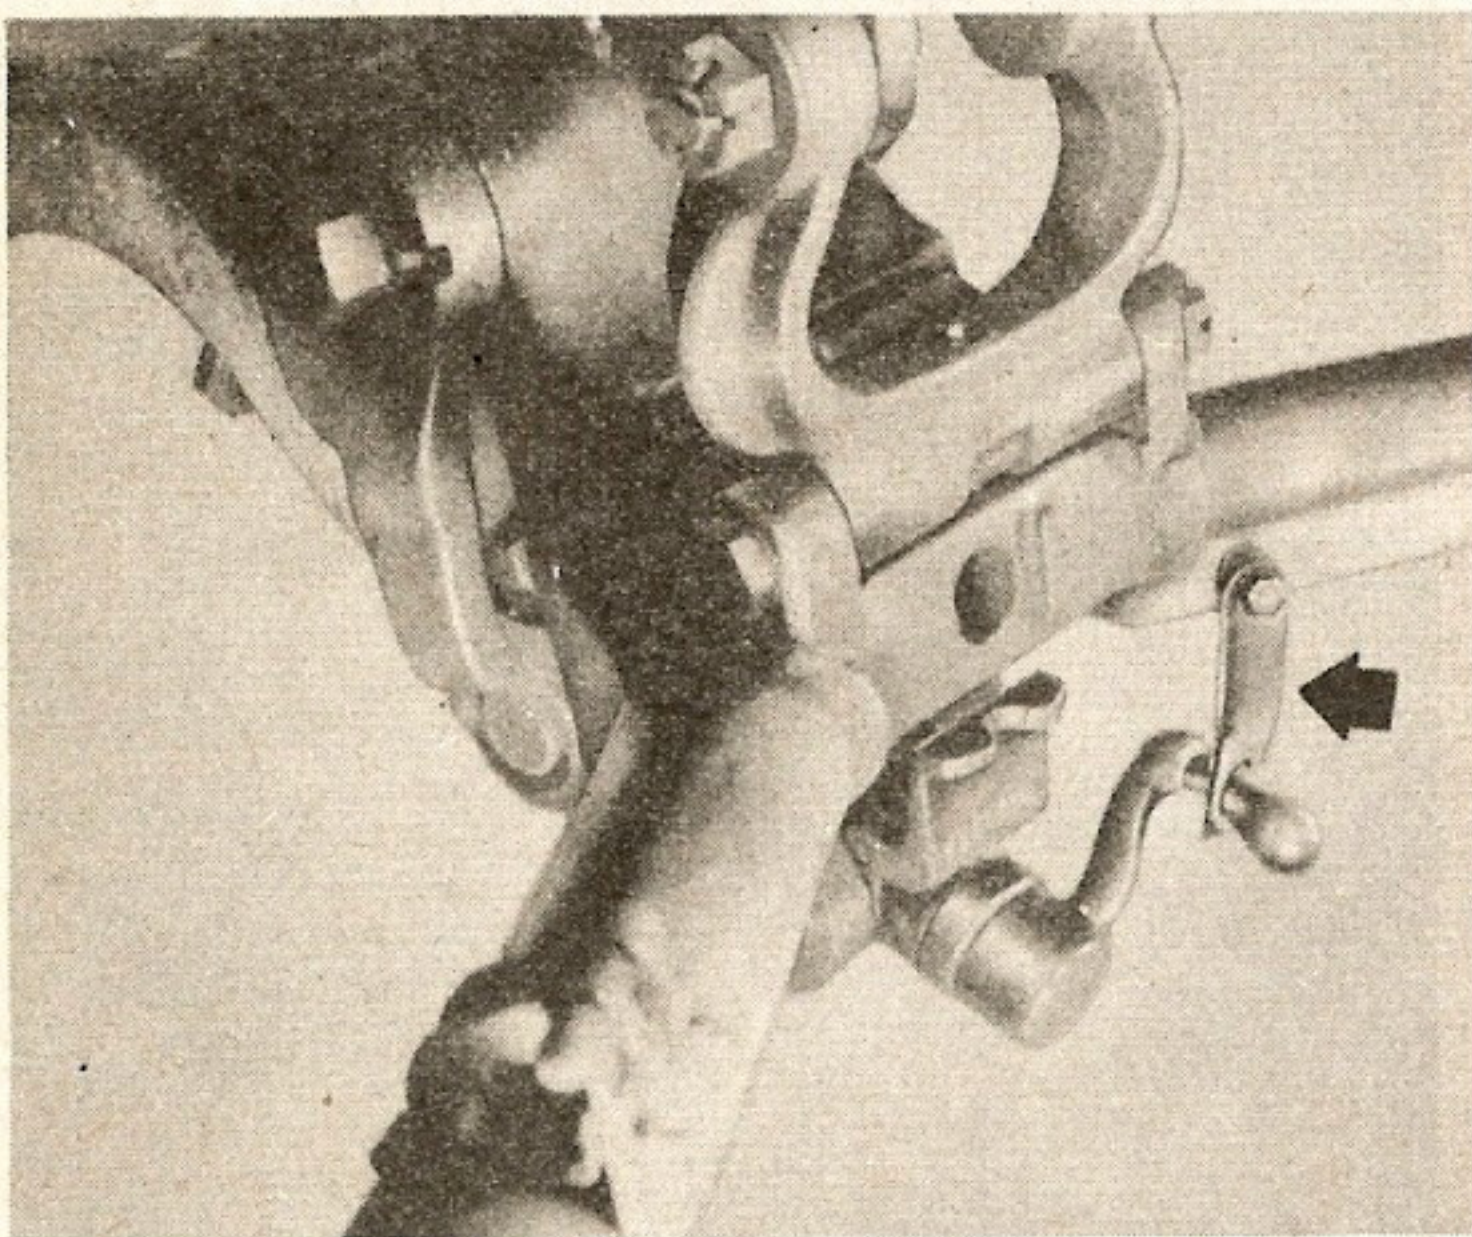
That little adjustable lunette handle on the M5 bomb trailer, that's been getting knocked galley-west every time the trailer's third wheel makes a complete turn, won't give you any more trouble.

Take a strip of $\frac{1}{8}$ " steel plate $4\frac{3}{4}$ " long and 1" wide, round off the ends to a nice smooth $\frac{1}{2}$ " radius. Cut a $\frac{1}{4}$ " hole $\frac{1}{2}$ " from one end, and another hole $1" \times \frac{1}{2}"$ the same distance from the other end. Slot the larger hole to the side, with a $\frac{1}{2}$ " opening, (see Fig. 1 above) and give the bracket a slight twist ($9/32^\circ$) with the slot to the right.

To mount this handle holder, cut a $\frac{1}{4}$ " hole in the right-front-side hitch-yoke-assembly, $1\frac{1}{8}$ " from the center (Fig. 2 at left). Use a bolt ($1\frac{1}{4} \times \frac{1}{4}$ ") from the back, then a round flat washer ($\frac{1}{4}$ "), a small, stiff spring ($\frac{1}{2}$ " long). Slip on the bracket, screw the nut on, and there you are. Simple little job, and it'll hold that handle in place until you're ready to adjust the lunette. Then there'll be plenty of clearance for that third wheel to whip around.

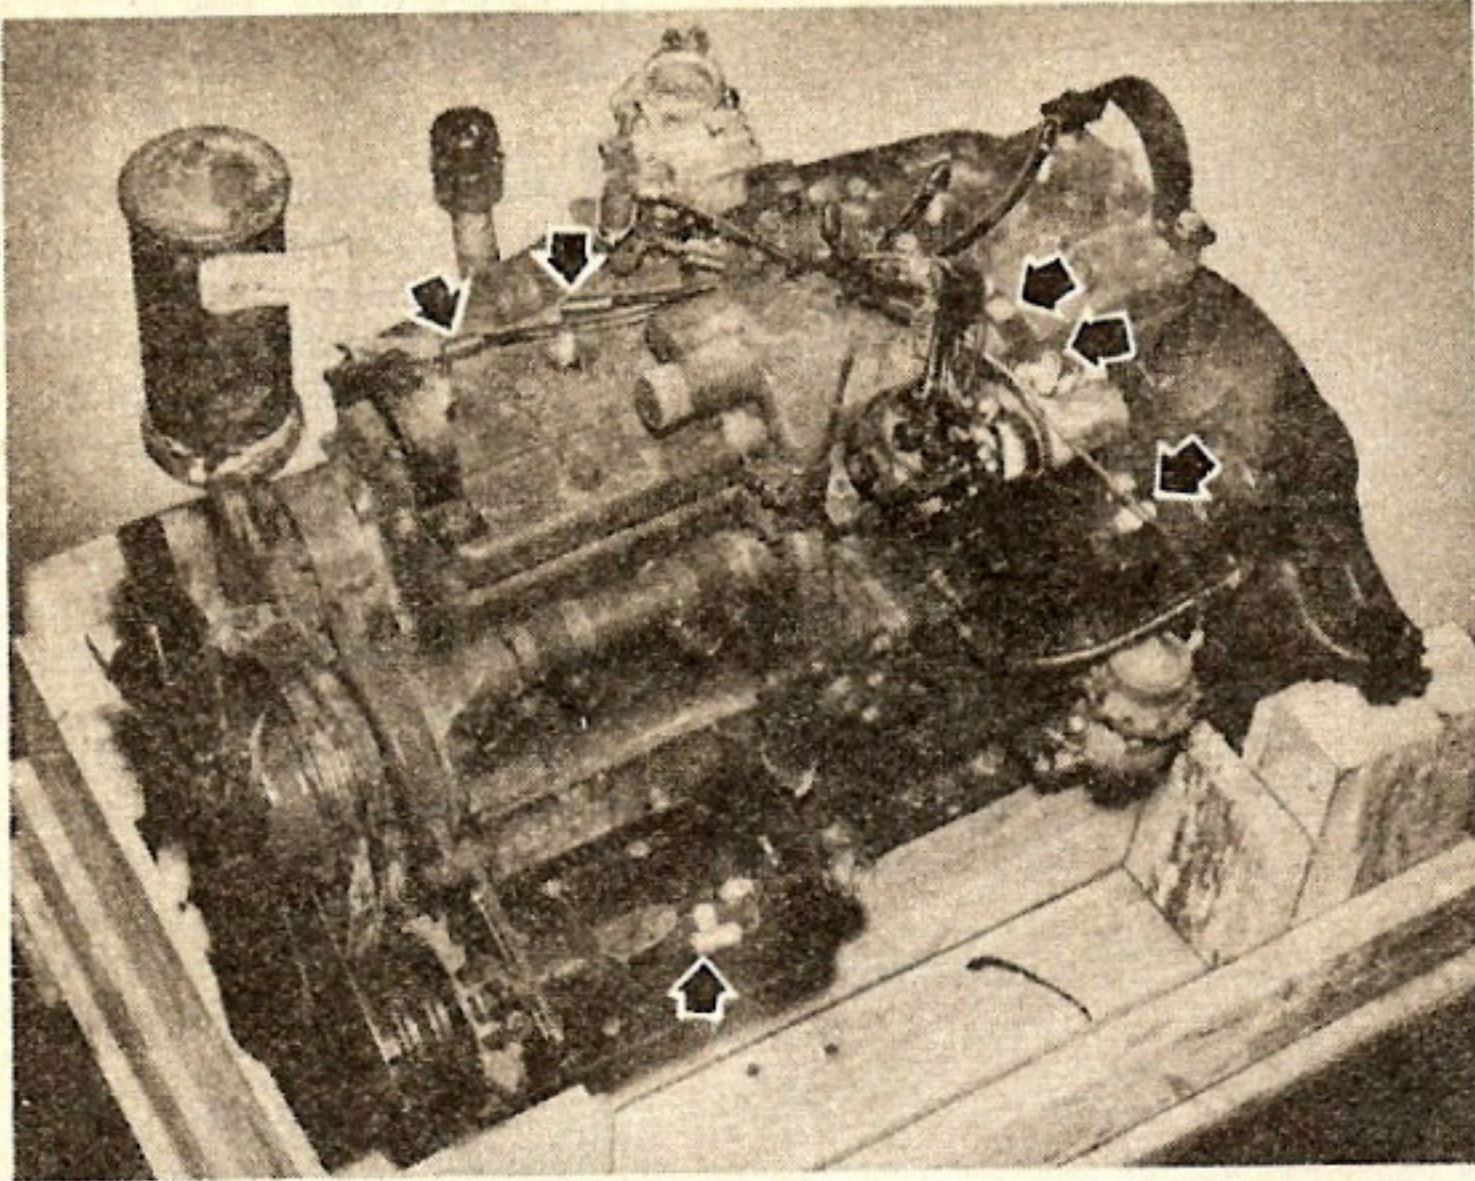
Take a look at the next replacement engine you get for your half-track—if it looks like the one in the picture at left it's already suppressed, so don't start yanking pieces off to install other devices.

Lots of guys have been pulling all the arrowed-parts off and replacing them with old-style suppression equipment pictured below. That's bad.
