SIGNAL CORPS

Technical Information Letter

JULY

1945

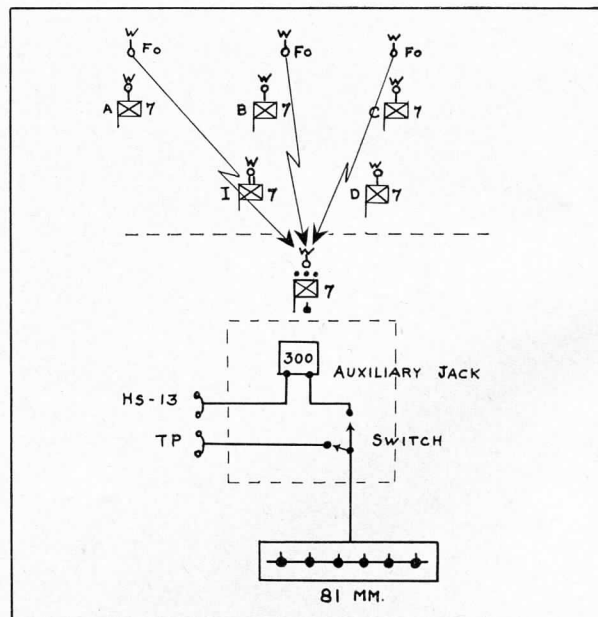
REPRESENTATION OF SET-UP FOR USE OF SCR-300 IN MORTAR FIRE DIRECTION.

Range of the SCR-300 was increased by elevat-

ing it to a roof or hilltop and operating it by means of remote control hook-up.

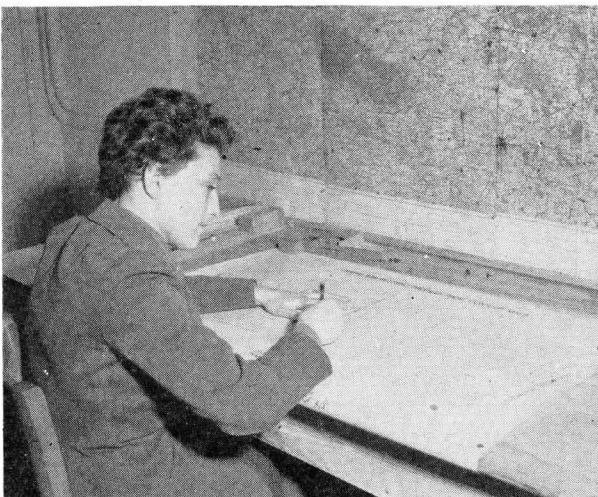
PROFILE MAP IS BEING PLOTTED FOR INSTALLATION OF RADIO RELAY EQUIPMENT.

The initial circuit request came through at 0900 hours 23 —. A tentative target date for activation was set at 2400 hours 25 —. As soon as termination details were known, work commenced on circuit planning, and as in previous instances, a series of route possibilities were selected from 1:250,000 scale maps. Then two of the more promising possibilities developed into full-scale studies utilizing the more accurate maps. Both of these studies developed along similar lines, and in the final analysis, there was no outstanding reason to favor either one. Since all v-h-f terminals in Paris are operated from a central high-point with the resultant possibility of securing excellent distances on the first signal path, it was decided to make this first path approximately 40 miles; the second and third, 35 miles, and from the last relay to the far terminal, approximately 25 miles; this latter distance being dictated by unfavorable terrain features. None of these signal paths was excessive, and from an examination of the completed profile study, a confident prediction of a quiet circuit, free of fading could be made.

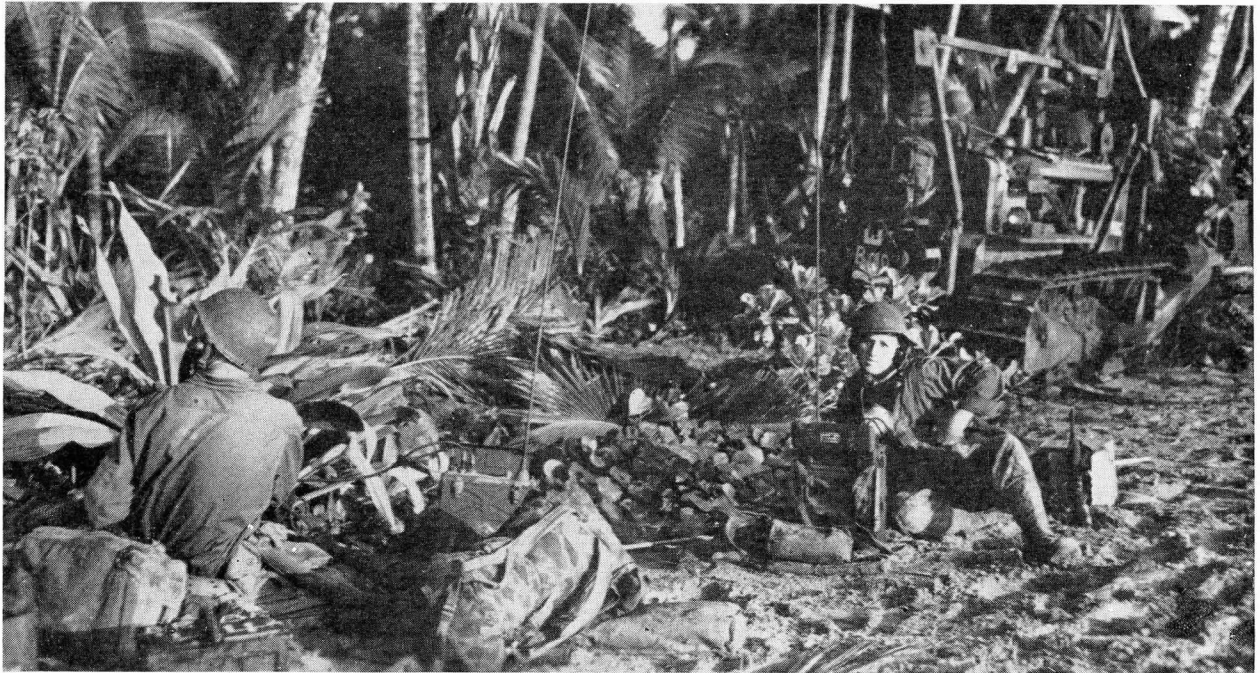
TWO SCR-300'S IN USE IN A JUNGLE CLEARING ON A PACIFIC ISLAND. A BULLDOZER, IN REAR, TIDIES UP THE AREA.

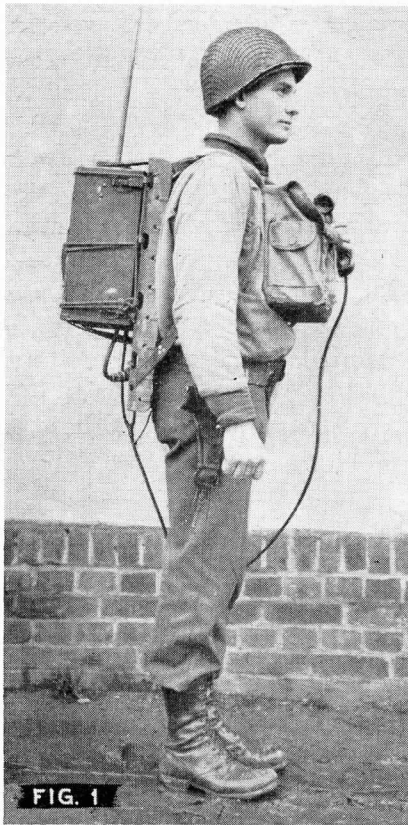
FIG. 1

THE PHOTOGRAPHS shown (figs. 1, 2, and 3) indicate a method of man-packing Radio Set SCR-509 devised in the European Theater of Operations. The receiver-transmitter is carried on a standard packboard and the batteries are carried in a musette bag. The total weight of the set and pack equipment is approximately 60 pounds.
